ATSB TRANSPORT SAFETY INVESTIGATION REPORT  
Marine Occurrence Investigation No. 227  
Final

Independent investigation into the grounding of the  
Singapore registered woodchip carrier

# Crimson Mars

in the River Tamar, Tasmania

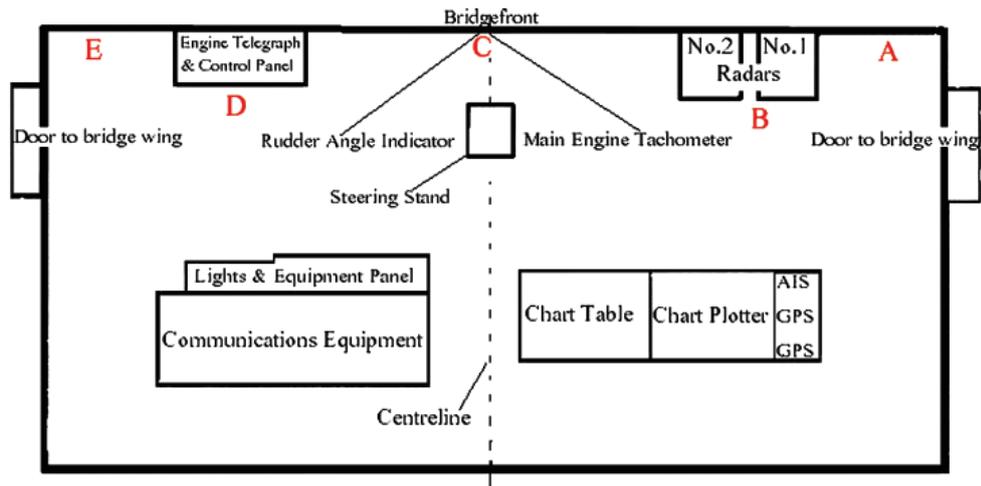
Figure 2: *Crimson Mars's* bridge layout with details relevant to the incident

*Crimson Mars's* general arrangement (GA) plan identified a 'conning position' on the centreline inside the bridge (position C in Figure 2), and because the view forward from this position was obscured by the cranes, two 'additional conning positions' (A and E) 4.80 m on either side of the centreline. Each position was about 0.30 m aft of the bridge front and all three were prominently indicated by identical signs with the words 'CONNING PT.' painted in red on the bridge front. The rudder angle indicator was clearly readable from the centreline conning position, but could not be read from either additional conning position.

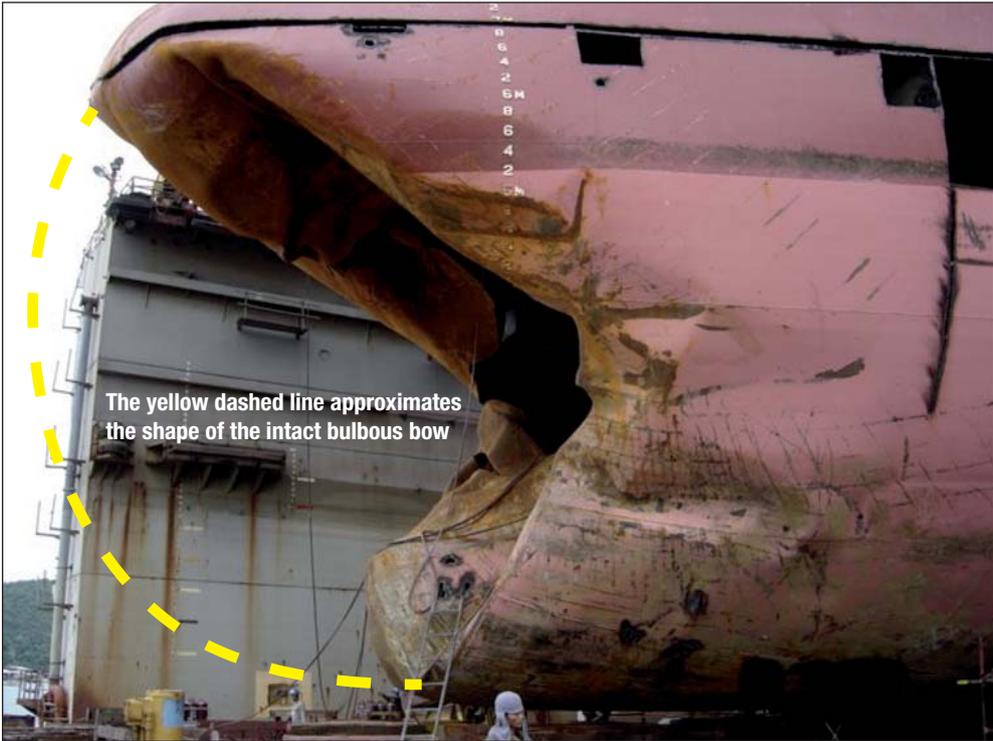
**Figure 5: The damaged bulbous bow seen from the port side**

While at anchor, an underwater inspection by a diver revealed that the ship's bulbous bow had been pushed in leaving a hole about five to six metres wide and three metres high, giving it a 'mouth like' appearance. The diver could easily access the fore peak tank through the holed bow and found a substantial amount of material from the seabed deposited inside. Indentations and paint damage aft of the bulbous bow were also evident. The damage described in the diver's report is evident in photographs taken during the subsequent repairs in dry dock (Figures 5 and 6).

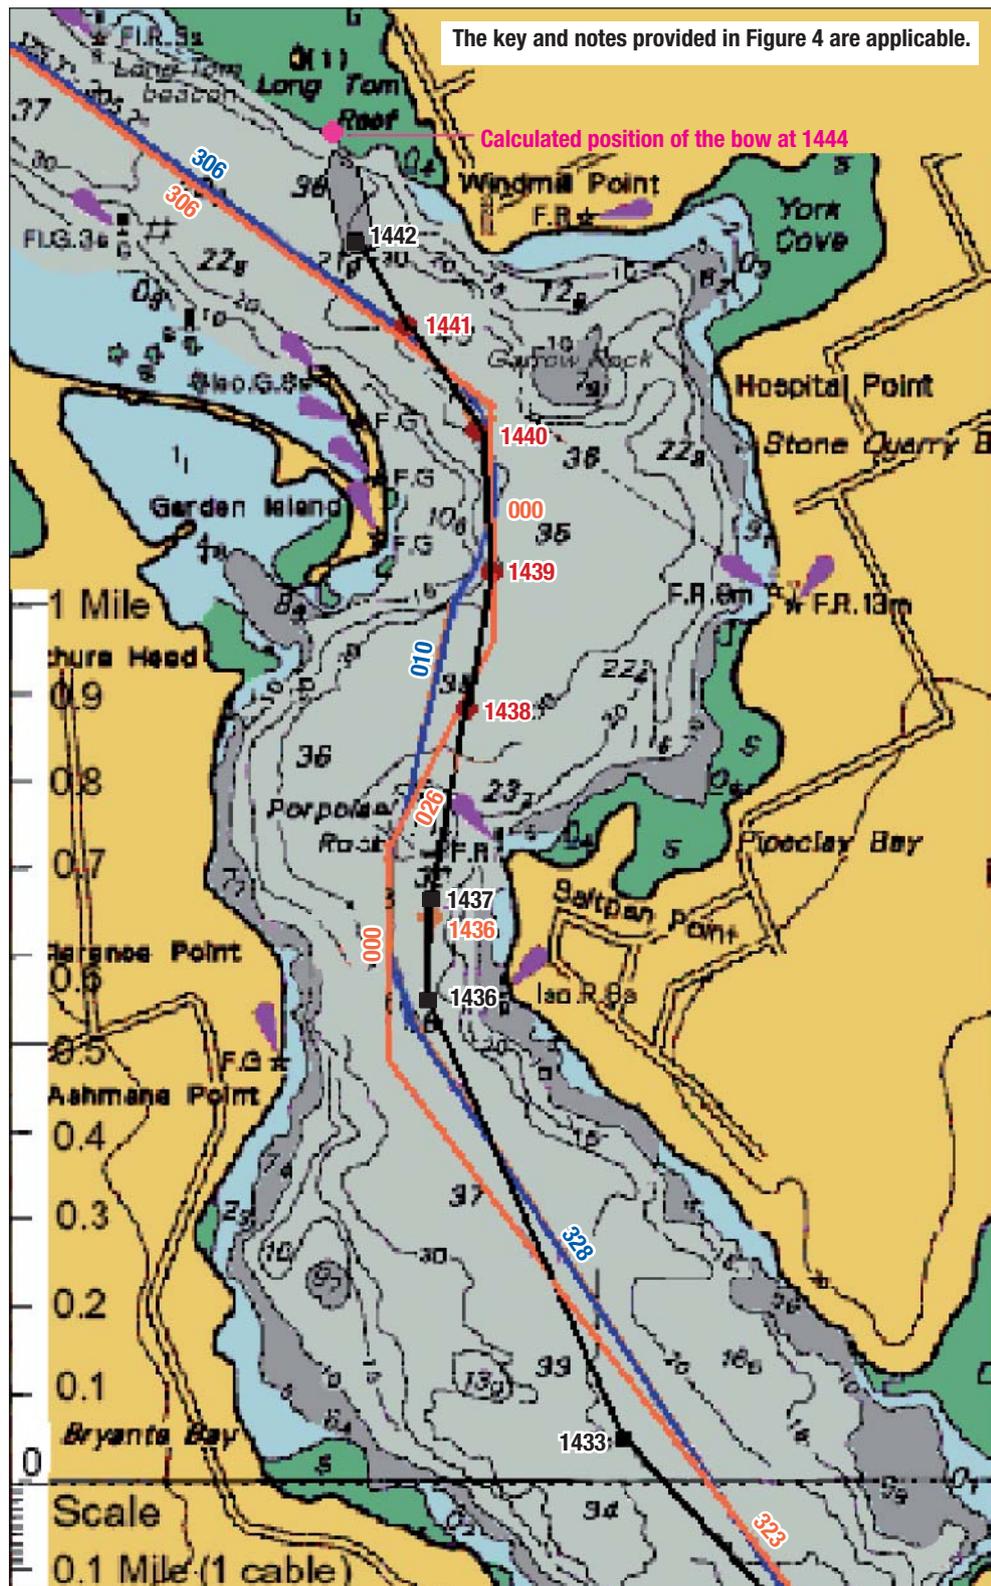
Figure 7: *Crimson Mars's* grounding on Long Tom Reef

The position at 1444 was the northernmost recorded and the calculated position of the bow at this time was the furthest extent of the ship's grounding on the reef (Figure 7). The ship then moved astern in a south-easterly direction and at 1444½ its speed was 1.8 knots with sternway increasing. The ship was afloat at 1446 and dragged the anchor until the windlass failed and the main engine was stopped at 1448½.

The ship grounded on a heading that was nearly at right angles to Long Tom Reef. The edge of the reef rises steeply rather than a gentle slope from the adjacent deep water. This prevented the ship from moving too far onto the reef, and the impact was absorbed mainly by its bulbous bow. Significantly, several fuel oil tanks located aft of the number one ballast tanks along the bottom of the ship's hull remained intact. Had the ship grounded at a different angle, the hull could have been damaged further aft by a glancing blow which would have probably resulted in oil pollution from ruptured fuel oil tanks.

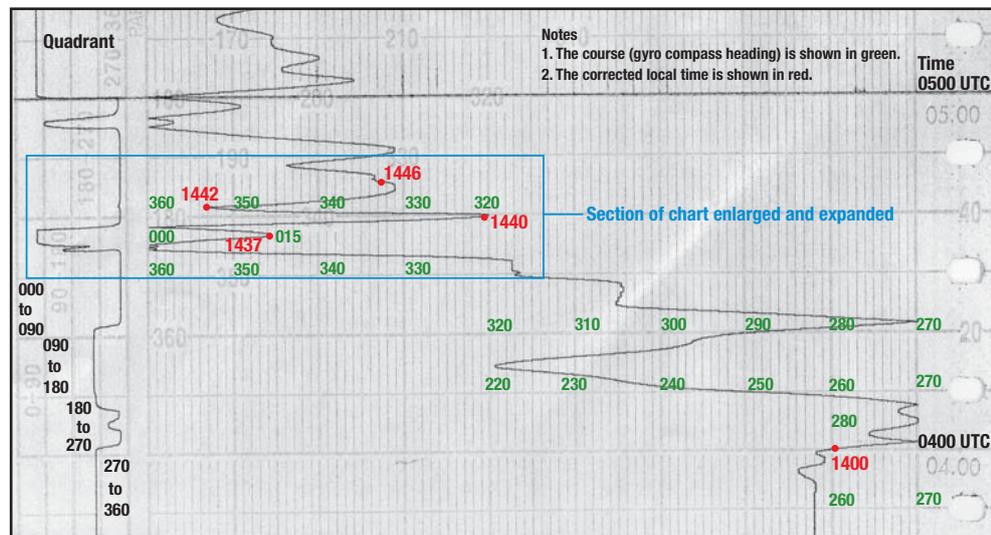
**Figure 8: Course recorder chart**

At 1439½, the heading was 329° and the average rate of turn to port since 1439 was 32° per minute, but decreasing. Soon after, the turn to port slowed significantly and at 1440 stopped with the heading on 320° before a turn to starboard developed. The rate of turn to starboard increased with the heading passing 343° at 1441, after which the swing slowed under maximum port helm. At 1442, the heading was 353° and, as the ship grounded, its heading immediately swung to port.

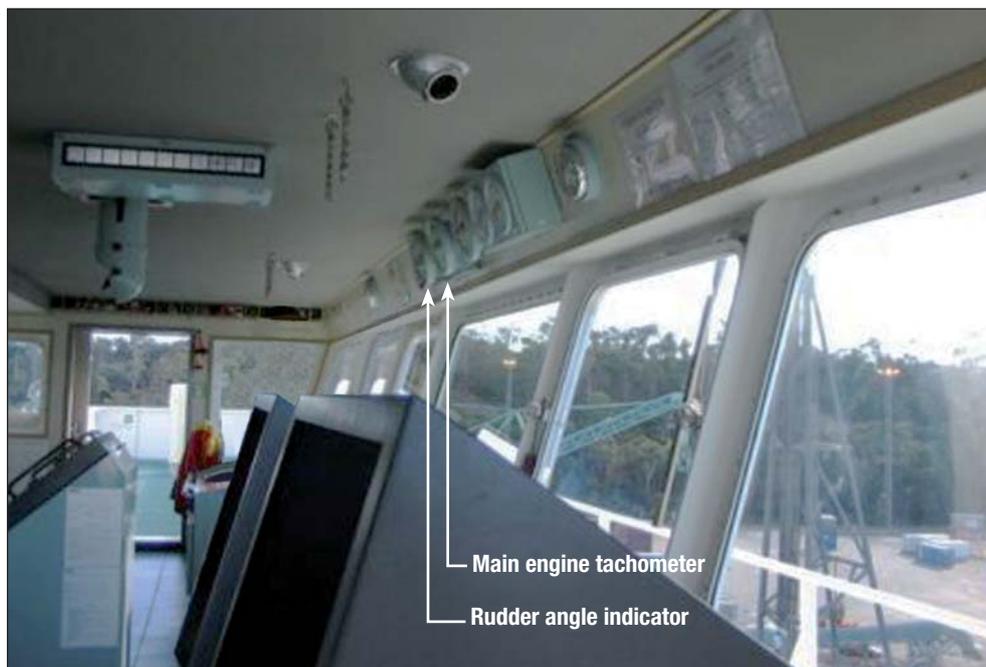
Figure 10: The view from the starboard additional conning position

From about 1423, the pilot conned the ship from the starboard additional conning position (Figure 10). He could not read the rudder angle indicator from that position. When he moved from there to check the rudder angle just after 1440 he observed that the rudder was nearly hard-over to starboard and not to port as he had intended. If the incorrect use of starboard rudder had been observed earlier the grounding may have been prevented.

- Pilots and masters should ensure that they are able to read, or otherwise be able to check, the rudder angle when conning a ship. They should also ensure that the conventions governing helm orders are observed, particularly the use of 'midships' when changing rudder direction, and 'closing the loop' when communicating orders to a helmsman. The use of hand signals to enhance the communication of helm orders should also be considered.
