ATSB TRANSPORT SAFETY INVESTIGATION REPORT  
Marine Occurrence Investigation No. 254  
Final

# Francoise Gilot

in Port Phillip, Victoria  
9 May 2008

MO-2008-006

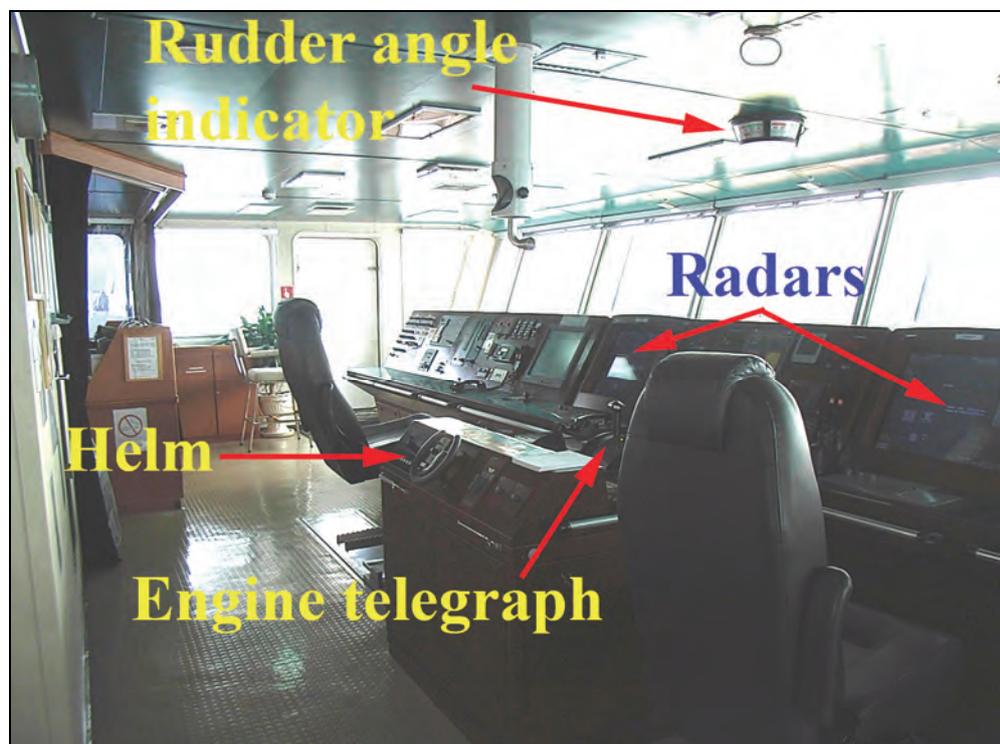
**Figures 2: Steering position and location of rudder angle indicator**

The ship’s helm is located behind the engine and associated machinery control panels in the wheelhouse (Figure 2). This position is between the ship’s radar displays and has a clear view of the three-faced rudder angle indicator, which is mounted on the centreline of the wheelhouse deckhead.

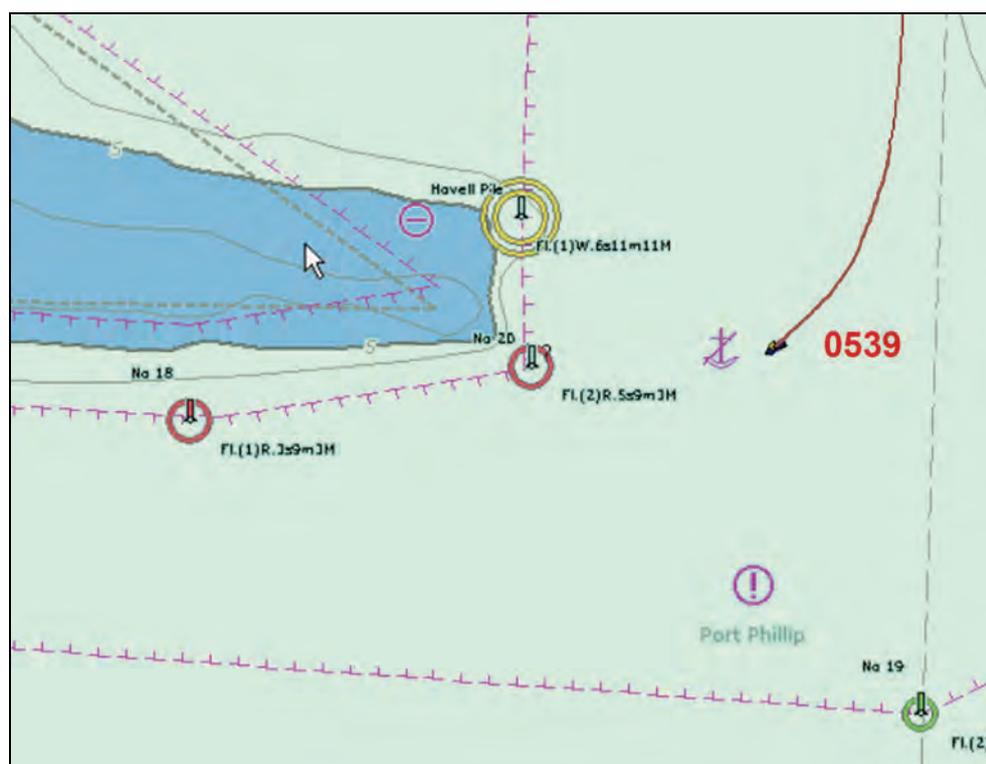
**Figure 6: Port of Melbourne's AIS image of *Francoise Gilot's* position at 0539 (ship-shape not to scale)**

At 0537½, with the Rosebud Jetty 1.6 miles ahead, the pilot ordered 'starboard five'. At 0538, the ship's RoT to starboard was 44 degrees per minute and in order to slow the starboard RoT, the pilot ordered 'midships', then 'port five' and shortly

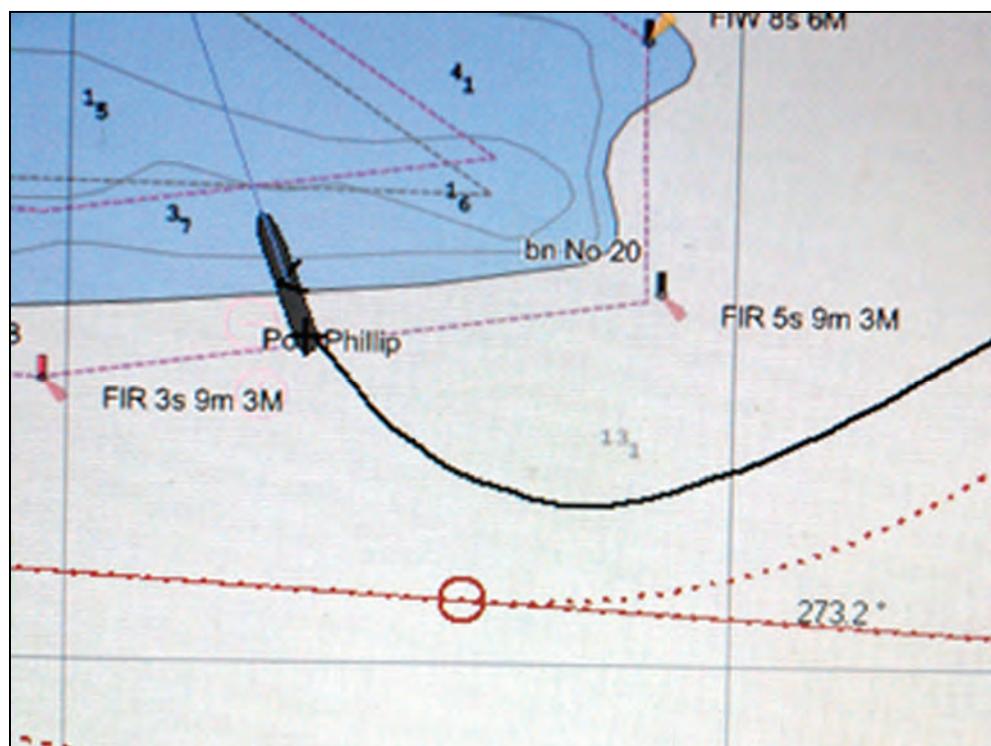
**Figure 7: Pilot's electronic chart image showing ship's track and final grounding position (ship-shape to scale)**

At about 0541, despite a number of engine and rudder movements, *Francoise Gilot* grounded between beacons 18 and 20 in position 38°19.8'S 144°53.7'E, on a

heading of about 340° (T) (Figure 7). About half the ship's length had passed over the toe line of the channel before the ship came to a complete stop.

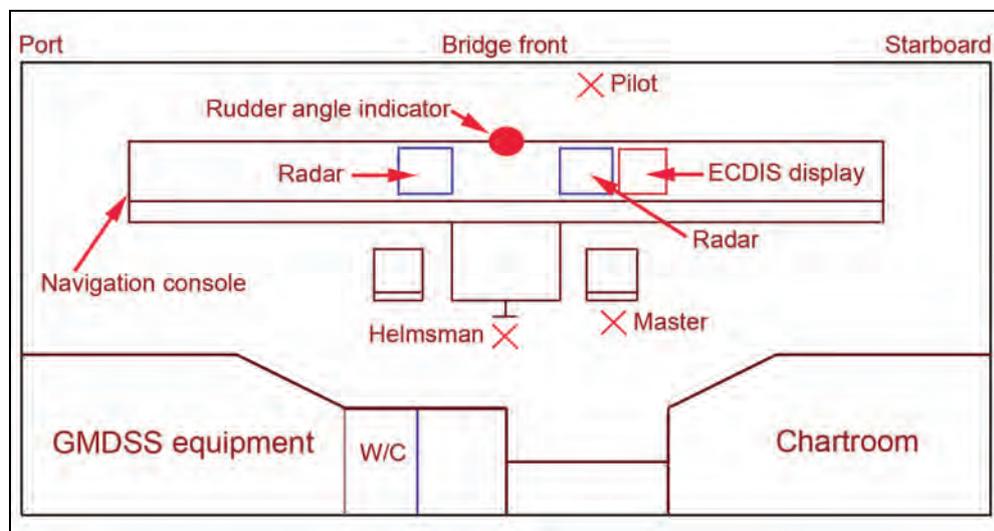
**Figure 8: Diagram showing general bridge layout and the positions of the pilot, the master and the helmsman (drawing not to scale)**

The pilot used closed-loop communications<sup>12</sup> when he gave his helm orders and used hand signals to enhance his verbal orders. However, the helmsman was concentrating mainly on the ship's heading and did not take any notice of the hand signals. Had he done so, he may have been prompted to follow the hand signals and this, combined with the pilot's verbal orders, should have resulted in him putting the helm in the correct direction.

The master was standing to starboard of the helmsman looking at the ship's radar and electronic charting display information system (ECDIS) displays (Figure 8) and from there he could easily see the rudder angle indicator and the helm. However, he

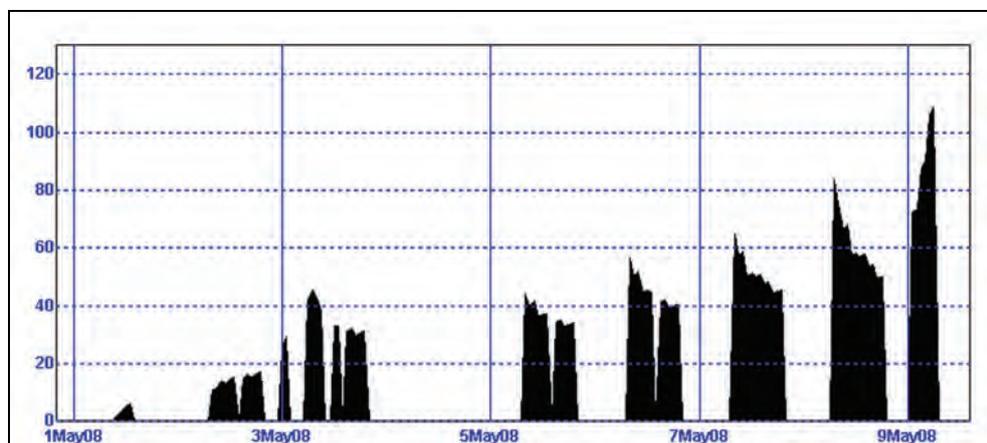
**Figure 9: FAID graph showing the helmsman's fatigue scores during period leading up to the grounding**

The FAID analysis for the helmsman (Figure 9) shows a score of 108.5 immediately prior to the grounding. This score is considered to be in the very high range.

Based on the helmsman's working routine and his time awake, it is reasonable to conclude that he was affected by fatigue at the time of the grounding. As such, it is likely that he was operating at a level of alertness below that necessary to properly carry out his duties as helmsman.
