National Transportation Safety Board

Marine Accident Brief

Grounding of Bulk Carrier *Sparna*

Accident no.	DCA16FM032
Vessel name	<i>Sparna</i>
Accident type	Grounding
Location	Wauna Channel, Columbia River, about 50 miles northwest of Portland, Oregon
Date	March 20, 2016
Time	2337 Pacific daylight time (coordinated universal time – 7 hours)
Injuries	None
Property damage	>\$560,000 est.
Environmental damage	None
Weather	Overcast, no precipitation, winds <5 knots, air temperature 52°F
Waterway information	The Columbia River runs between the states of Oregon and Washington. It is the main conduit for deep-draft vessels to and from Portland/surrounding ports and the Pacific Ocean. At the time of the accident, the current was ebbing at 1–1.5 knots.

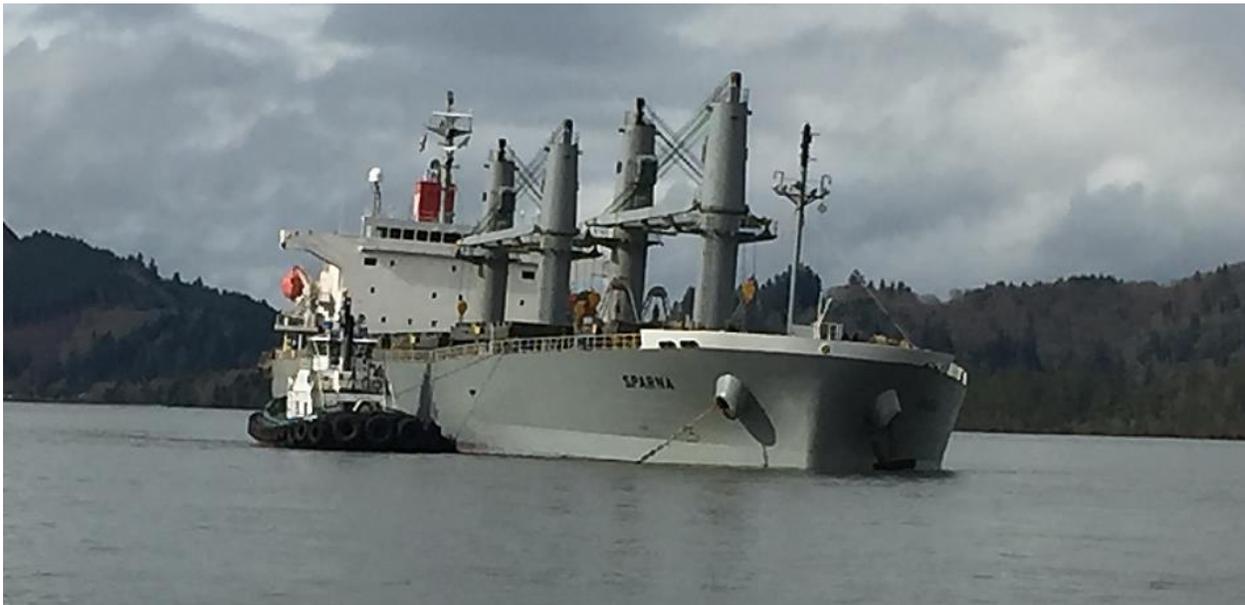
Just before midnight on March 20, 2016, the bulk carrier *Sparna* was transiting outbound on the Columbia River when it departed the navigation channel and struck a rocky shallow area. No one was injured and no pollution resulted, but the grounding caused damage and flooding to the vessel's forward tanks. Damage to the *Sparna* was estimated at more than \$500,000 and to a nearby dock about \$60,000.

The *Sparna* at anchor after the grounding. (Photo by US Coast Guard)

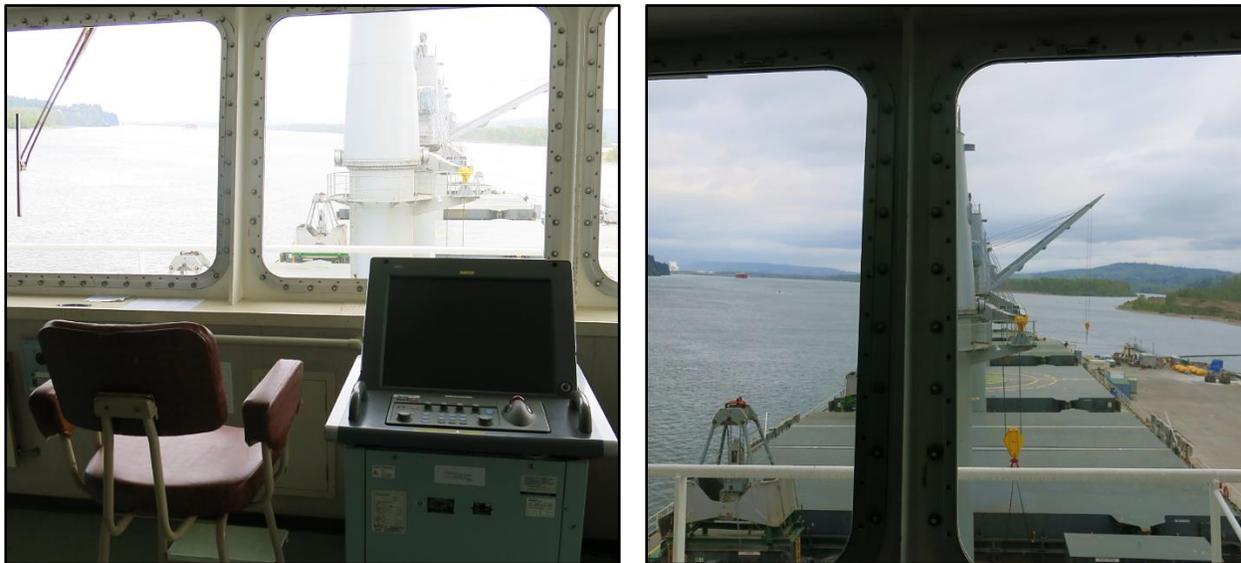
The *Sparna* navigation bridge: at left, the location of the pilot chair, which was about 5 feet from the ship's centerline; at right, the pilot's view forward from the chair. The images reveal the ship's list to port after the accident.

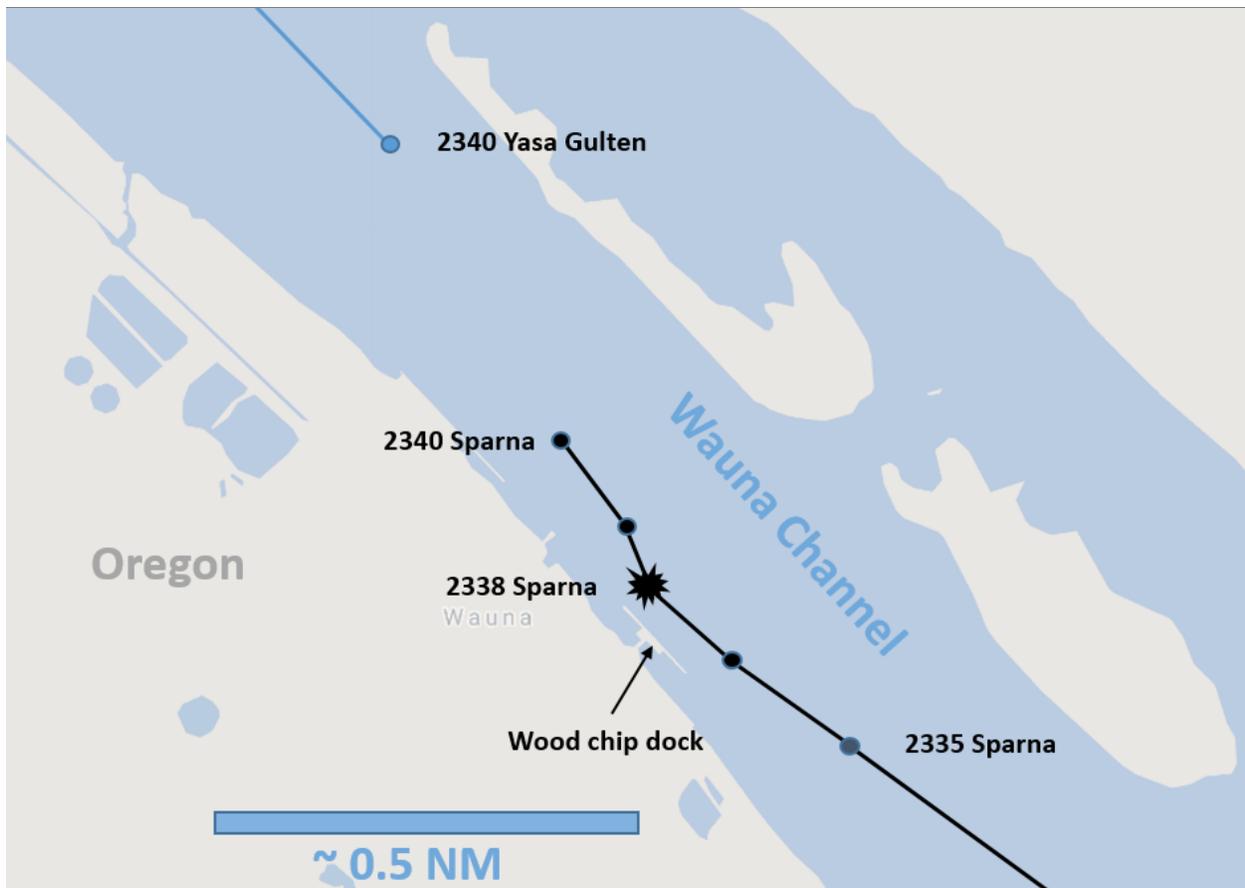
Track of the *Sparna* as the bulk carrier approached the wood chip dock and grounded. Times are rounded to the nearest minute. (Background by Google Maps)

About 26 seconds after his order of hard to port, the pilot requested the rudder to midship, which the helmsman applied. About 14 seconds after the midship order, while nearing the wood chip dock at a speed of 9.3 knots, the pilot ordered starboard 20 degrees. The helmsman acknowledged with “starboard twenty.” However, the rudder, which was still moving from the previous hard-to-port position toward midship, then began moving back to port, ultimately reaching port 20 degrees. Next, at 2335, the pilot requested slow-ahead speed. Immediately thereafter, the helmsman replied, “Rudder starboard twenty, sir.” However, the rudder was still at port 20 degrees. Neither the pilot nor the bridge team noticed the helmsman’s error.

As the ship continued to turn toward the wood chip dock and barges, the pilot ordered hard-to-starboard rudder and half-ahead speed, to which the helmsman replied, “Hard to starboard.” Yet, the VDR captured an initial increase to port before the rudder started moving toward hard to starboard. Seconds later, the pilot shouted, “Hard to starboard! Hard to starboard!” and ordered full-ahead speed. The helmsman replied, “Rudder coming hard to starboard now, sir.” At this time, the rudder indicated starboard 40 degrees and the engine 76 rpm. Both the pilot and the master then went to the port bridge wing to monitor the proximity of the *Sparna* to the barges at the Georgia Pacific dock. They did not activate any sound signals as the ship approached the dock. At 2336, the boatswain on the bow radioed the bridge and said that the *Sparna*’s port side was passing a barge at a distance of 1 meter. As the *Sparna*’s bow started to turn away from the barge, both the pilot and the master monitored the port quarter of the ship as it passed close to, but clear of, the barge. Next, the pilot ordered midship and then hard to port. He then radioed the pilot on the *Yasa Gulten* and said, “We’re coming your way.” The *Yasa Gulten* pilot acknowledged.

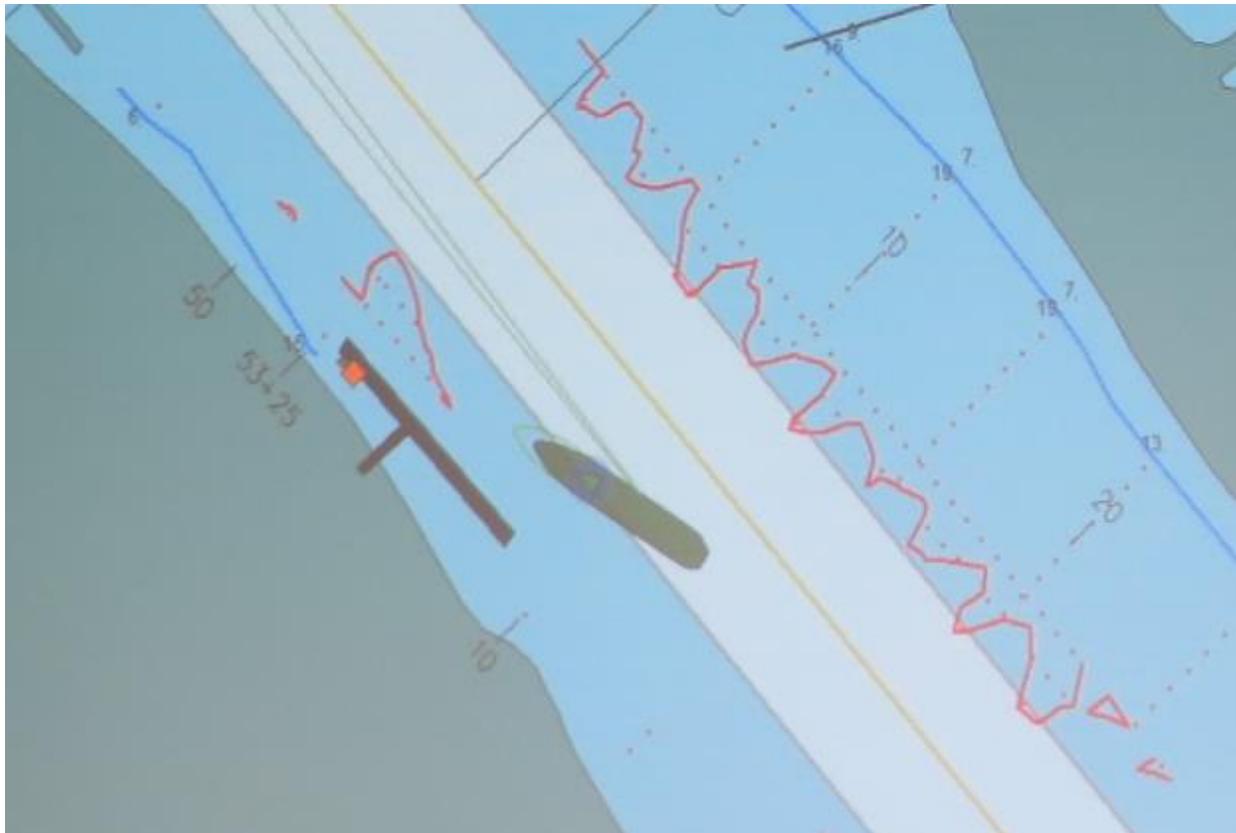
Screen shot of the playback from the pilot's PPU at 2336. Shallow areas are outlined in red.

At 2337, the *Sparna* VDR recorded a series of bangs, vibration noise, and the water speed decreasing from 8.5 knots to 3.5 knots as the vessel struck a charted shallow rock area just off the wood chip dock. As the ship headed back into the channel, the pilot continued giving helm orders to stabilize the ship's heading. Then, at 2338, the VDR recorded the boatswain on the ship's internal radio speaking in a raised and excited voice in Bengali. When interviewed by investigators, he explained that he radioed the bridge after hearing a loud bang and the sound of air escaping from the forepeak vent valve on the portside deck near cargo hatch no. 1. The master informed the pilot that the boatswain said the ship was "going down forward." Indeed, the ship began to list to port as the *Sparna* passed the *Yasa Gulten* at a distance of 400–500 feet at 2341.

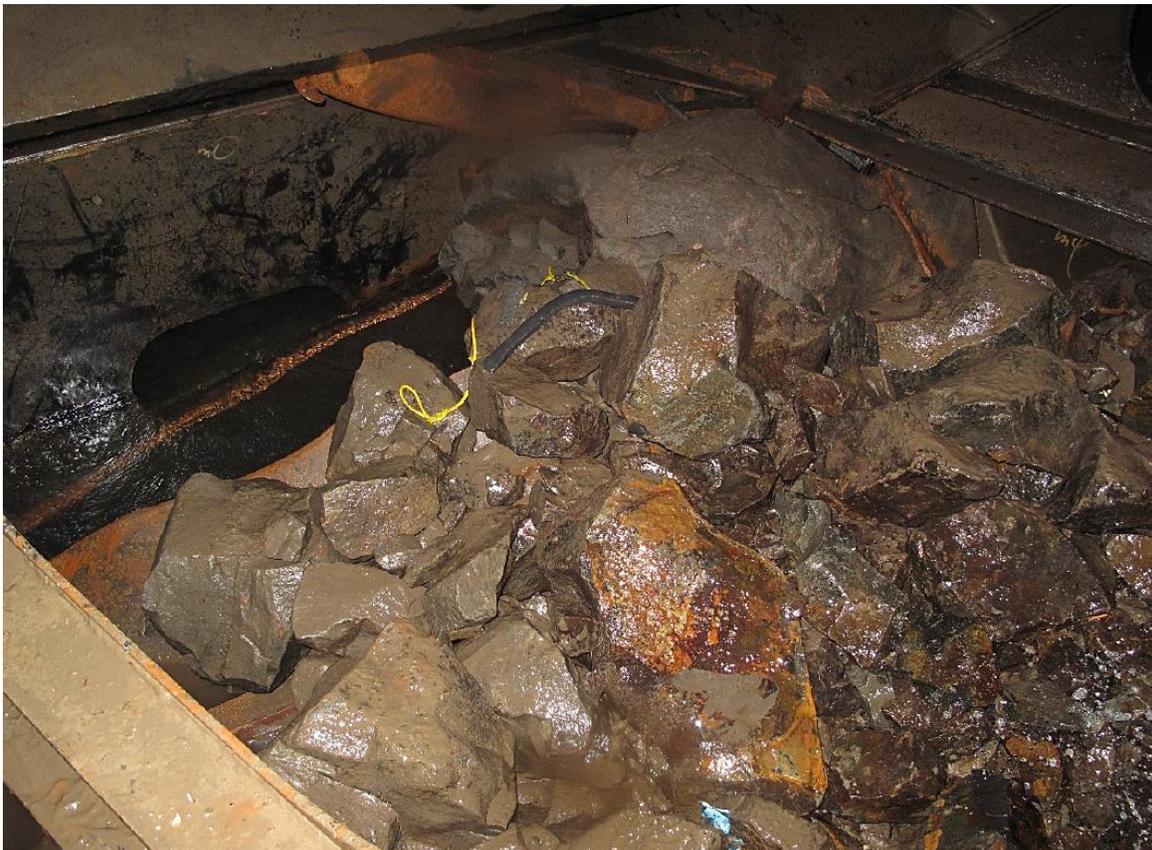
The *Sparna* sustained damage to the forward section of the hull, including scrapes, indentations, and fractures along the bottom near the bulbous bow on both the port and starboard sides. The forepeak tank on the starboard-side turn of the bilge sustained a breach about 10 feet long, 5 feet wide, and 7 feet tall, with a large piece of rock inside. The no. 1 portside ballast tank, from which the boatswain initially saw signs of flooding, had two penetrations, the largest about 25 feet long and 5 feet wide and the other about 6 feet long and 3 inches wide. A rock, about 3 feet by 4 feet, was embedded in the ballast tank.

Rocks inside the *Sparna*'s no. 1 portside ballast tank. (Photo by Donjon-Smit, LLC)
