MARINE SAFETY INVESTIGATION REPORT

Safety investigation into the grounding of the
Maltese registered bulk carrier

FLASH

on the Galitons de l'est
Ile de la Galite, Tunisia
on 25 June 2012

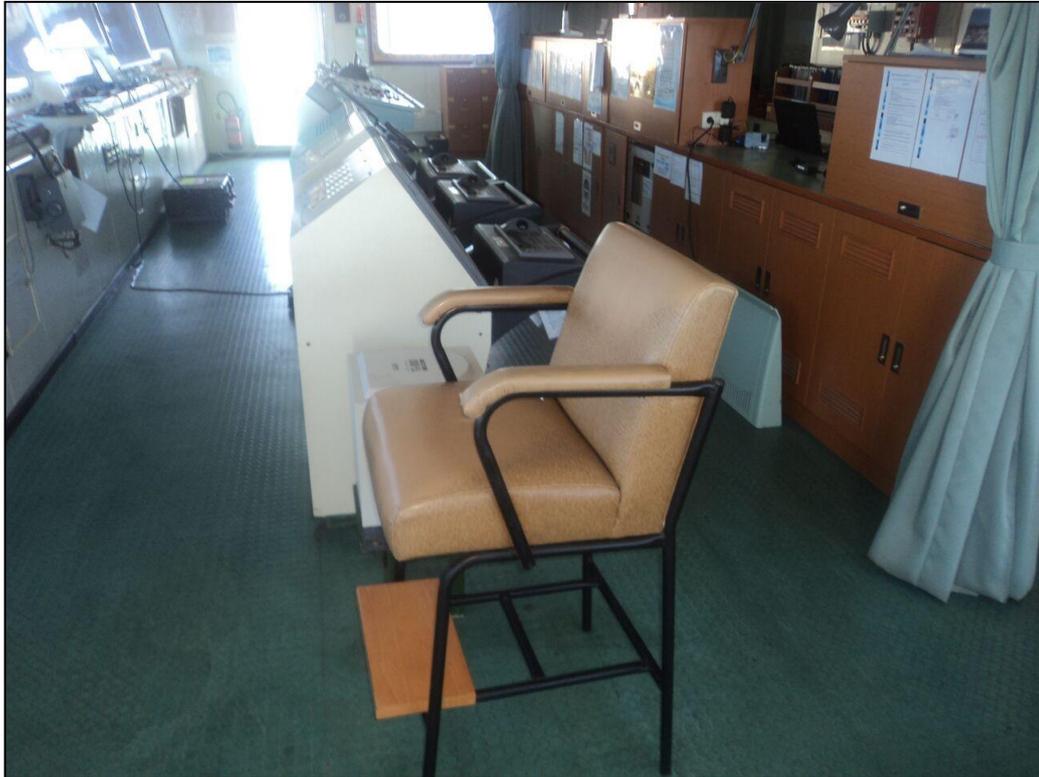
Figure 5: Navigation bridge layout and chair

The bridge was also equipped with a fully functional GMDSS radio station required for a vessel trading world-wide. The chair on the bridge was placed to the port side of the X-Band radar display (Figure 5).

At 0020, the OOW adjusted the autopilot by a few degrees to starboard but could not remember the exact heading. At 0030, the new course settled on 086°. The VDR-read course and speed over ground were 085°(T) and 11.7 knots respectively. Shortly afterwards, the OOW sat down on the bridge chair and fell asleep.

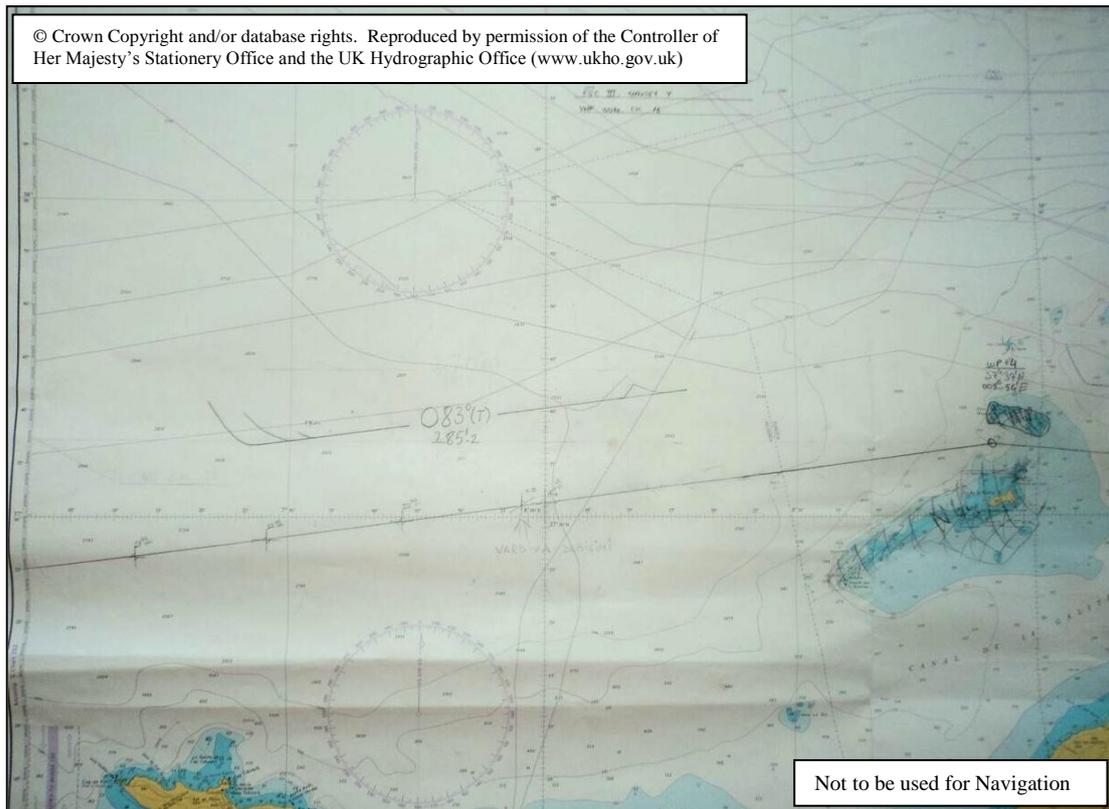
Figure 7: BA Chart 2121 with the actual plotted course

At 0330, *Flash* crossed the 100 m contour line and entered the shallow waters of Iles de la Galite (Figure 7). When the OOW woke up, the time was 0350. He claimed to have heard both the GPS and ECDIS alarms and saw an island ahead, at a distance of less than the ship's length². Using autopilot, he immediately put the helm 15° to port and set about checking the ship's position. The vessel was making good a speed of 12.5 knots but the action taken by the OOW was too late to clear the rocky shoals, which lay dead ahead (Figure 8).

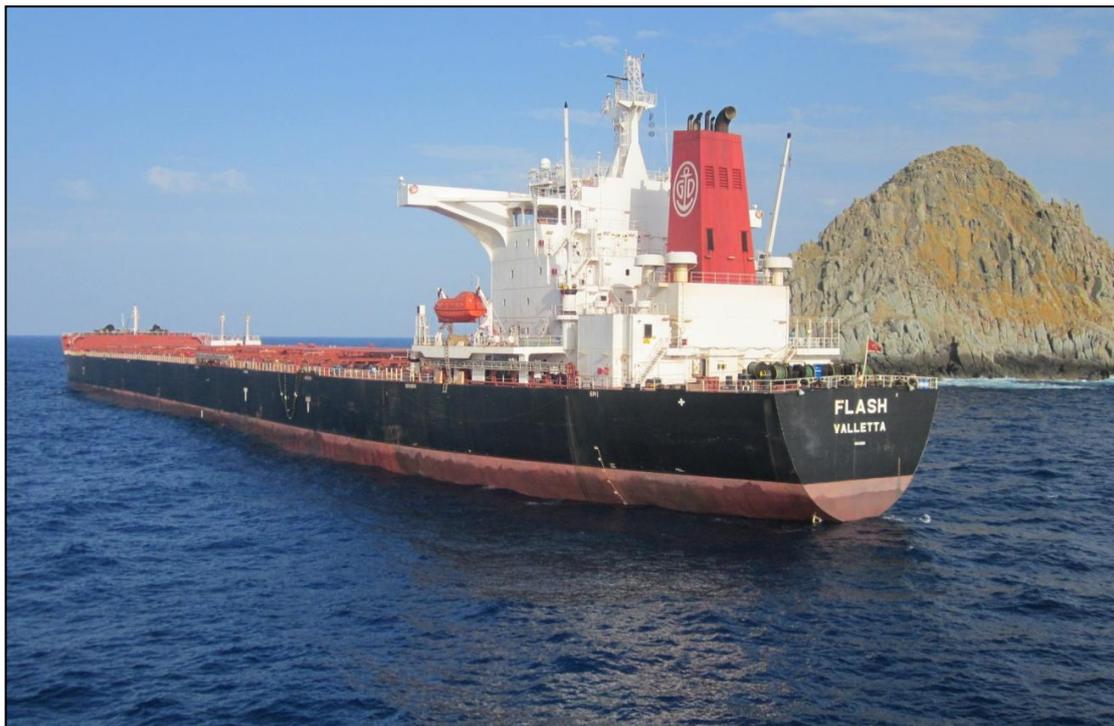
Figure 9: Flash stranded on the rocks of Galitons de l'est

On 25 June 2012, at about 0353, *Flash* grounded and remained stranded on the rocks of Galitons de l'est in position $37^{\circ} 33.69' N$ $008^{\circ} 57.17' E$ (Figure 9).

At the time of grounding, she had on board about 126,738 mt of coal distributed into its nine cargo holds, 2040 mt of IFO and 74 mt of MGO. She was drawing well over 14 m forward and 15 m aft. The vessel suffered severe structural damage to her

bottom hull, the fore peak tank, and several of her double bottom ballast tanks were breached and flooded.

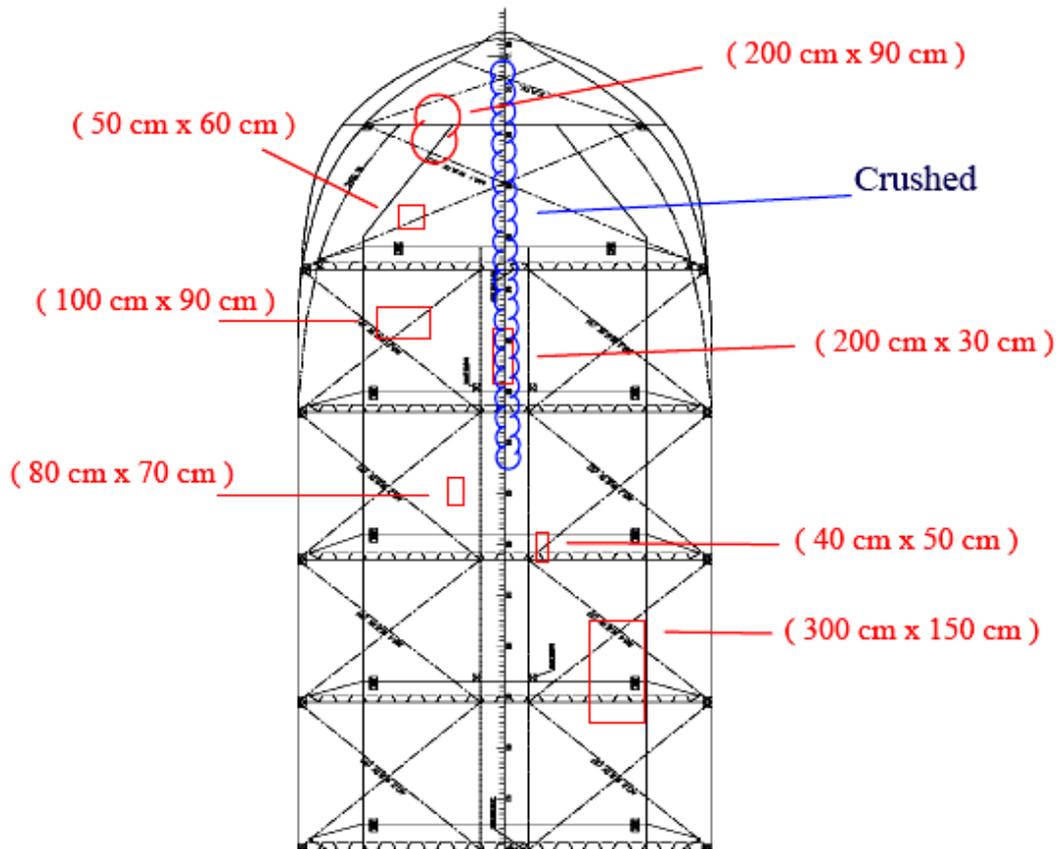
Figure 10: Damaged areas following the grounding

Subsequent to the grounding, the appointed salvors confirmed that the grounding was on a rock with 14 m of water around the vessel. The salvors survey confirmed flooding of the fore peak tank, the double bottom tanks nos. 1 centre, 2 starboard, 3 port and starboard, 4 starboard and 5 starboard (Figure 10). The engine-room was also flooded.
