ATSB TRANSPORT SAFETY REPORT
Marine Occurrence Investigation No. 274
MO-2010-003
Final

Independent investigation into the grounding of the
Chinese registered bulk carrier

Shen Neng 1

on Douglas Shoal, Queensland

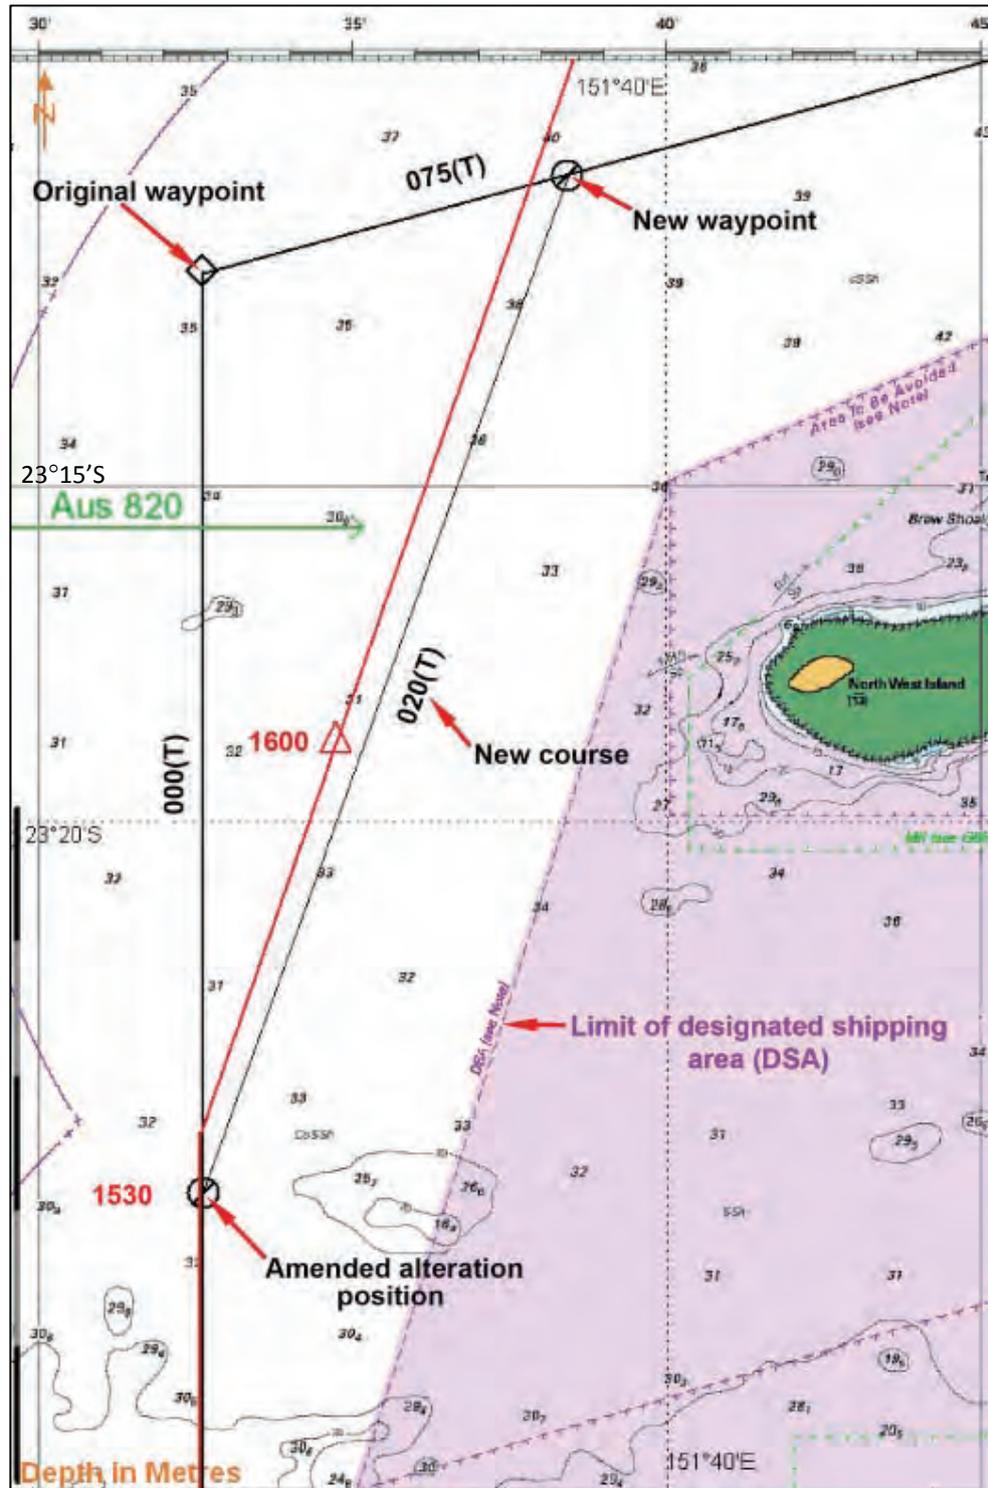
Shortly afterwards, the auto-pilot was engaged and the duty seaman posted as a lookout. The second mate asked the master if he could adjust the planned route to slightly reduce the distance of the voyage and indicated the proposed new track on the chart. This new course would amend the planned passage just off North West Island and bypass the next course alteration waypoint (from 000° (T) to 075° (T)). The new course would rejoin the 075° (T) track further to the east than planned, thereby reducing the distance by nearly 2 miles (Figure 5).

Figure 5: Annotated section of navigational chart Aus 819 showing the original and amended route, and the ship's position fixes (the red line indicates the ship's actual track)

When amending the passage plan, the second mate wrote the coordinates of the amended waypoints next to them on the charts but he did not enter these coordinates in the GPS unit.

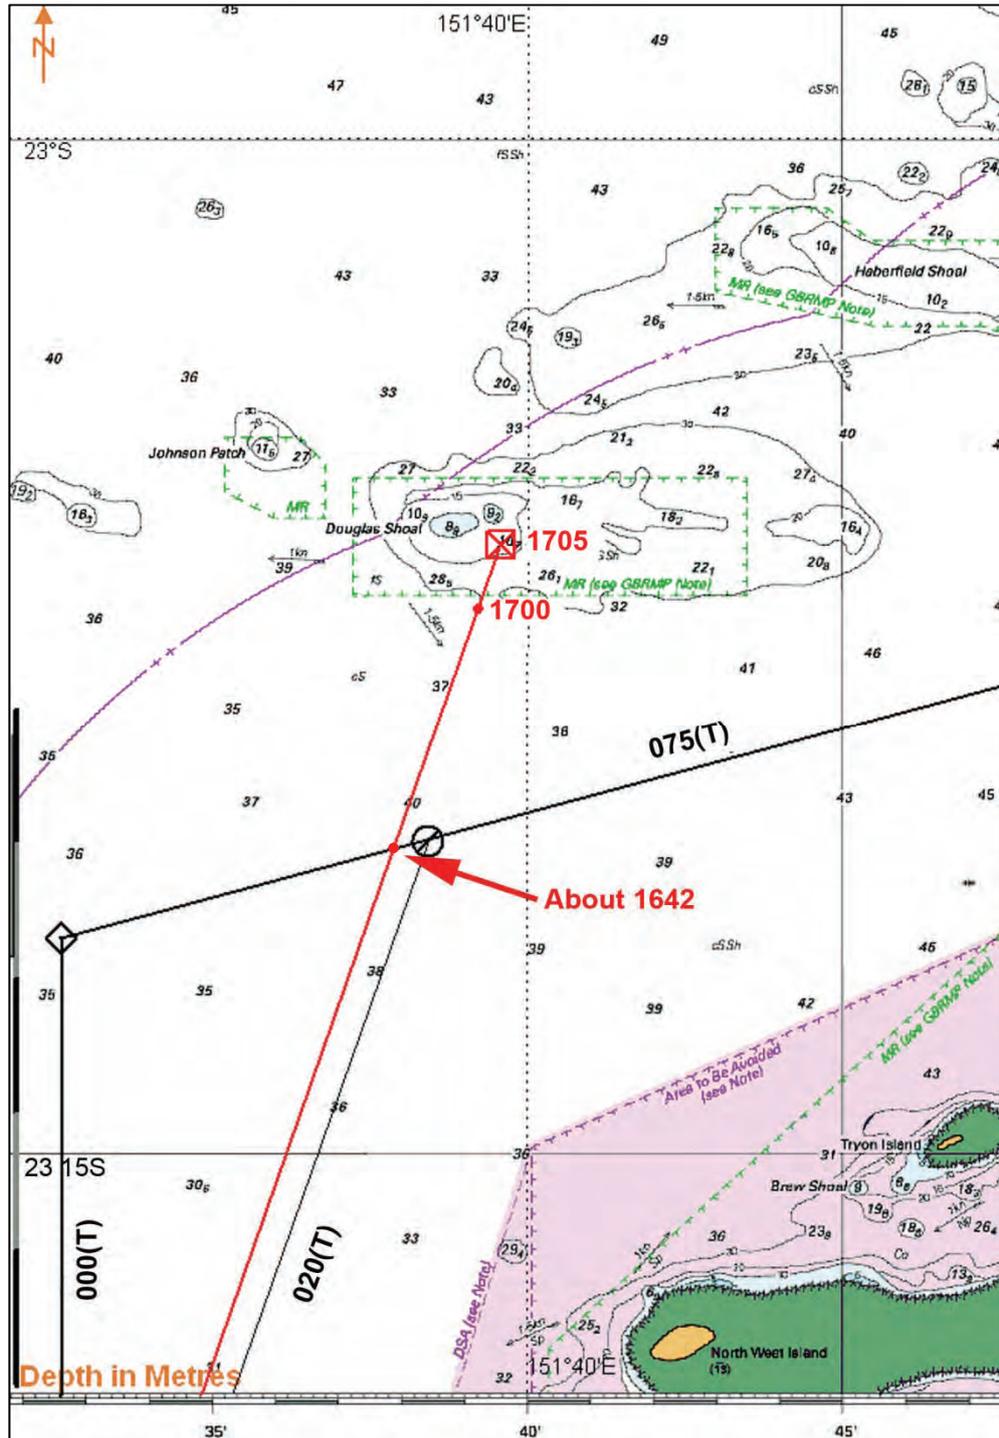
Figure 6: Annotated section of navigational chart Aus 820 showing the original and amended route, and the ship's grounding position

At about 1642, *Shen Neng 1* crossed the 075° (T) course line in the vicinity of the amended waypoint (Figure 6). On the ship's heading of 020° (T), Douglas Shoal was less than 5 miles ahead. The shoal, with a least depth of 8.9 m, gave no indication of its presence in the prevailing sea conditions.

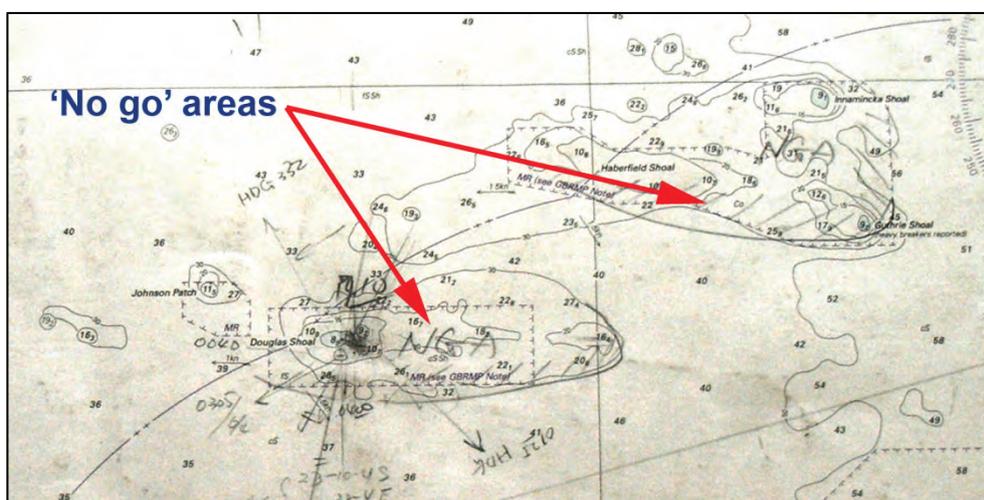
At about 1700, the chief mate recorded the GPS coordinates 23°07.0'S 151°39.2'E in the GPS log book. This position was not on chart Aus 819 and he took out chart Aus 820 from the chart table drawer so that he could plot the position. As he placed the chart on the chart table, he noticed the ship's speed had decreased to about 8 knots. He then saw the 'no go area' marked on the chart near the Marine Park boundary around Douglas Shoal and realised the ship was entering the boundary area and closing on the shoal (Figure 7).

Figure 7: *Shen Neng 1*'s navigational chart Aus 820 showing the 'no go areas' marked around Douglas and Guthrie/Haberfield Shoals

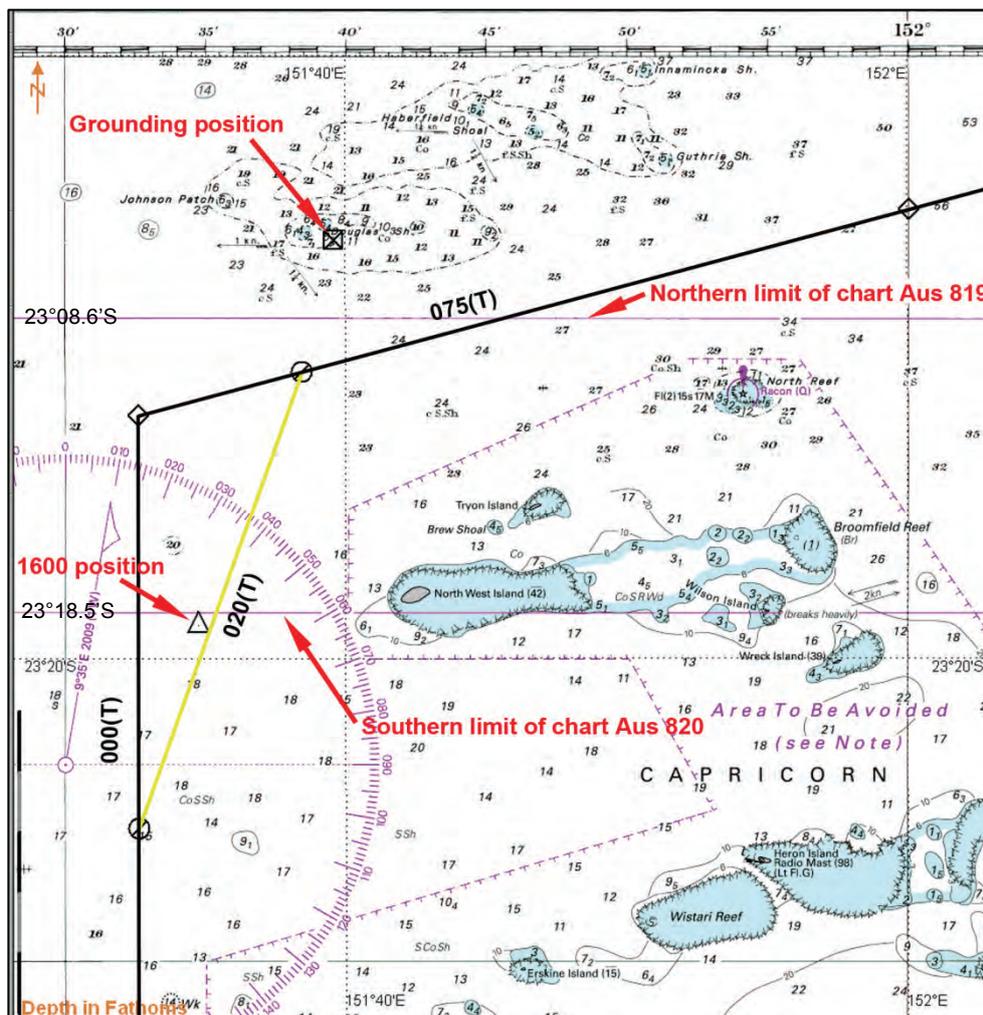
Figure 12: Section of navigational chart Aus 366 showing the limit of charts Aus 819 and Aus 820

By 1630, the ship would have travelled to a position where the most appropriate chart to use was Aus 820. However, no 1630 position was taken and so chart Aus 819 remained on the chart table until 1700. It was only then that the chief mate changed charts and saw the dangers ahead of the ship.

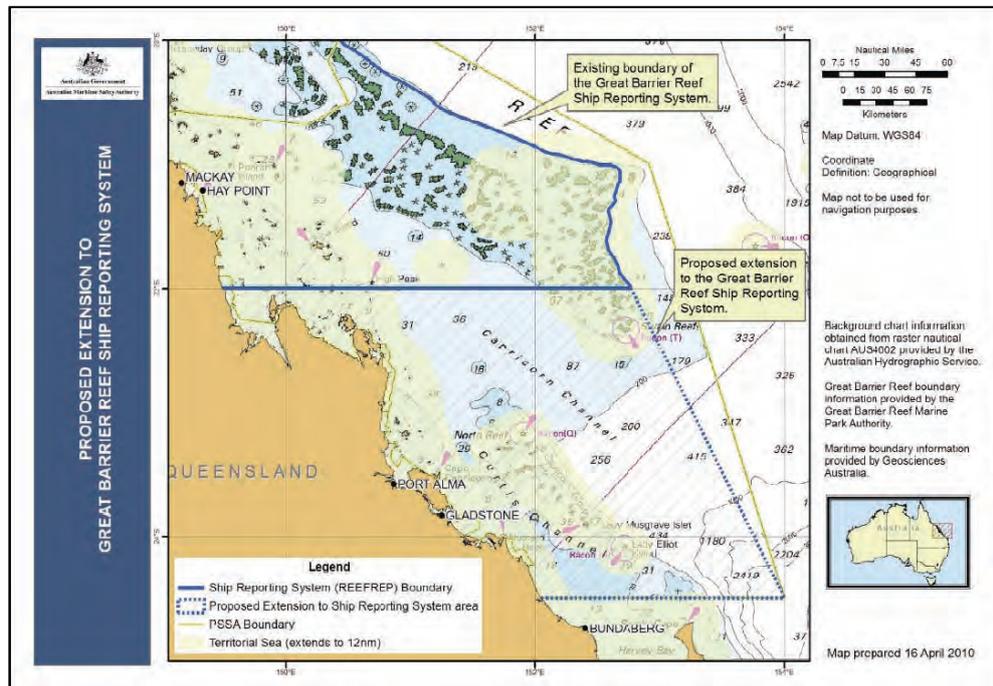
Figure 13: Extension of REEFVTS coverage to the southern boundary of the PSSA

In November 2010, the IMO agreed to AMSA's proposed extension of REEFVTS coverage to in the southern boundary of the PSSA.
