Report on the investigation of
the grounding of

Danio

off Longstone, Farne Islands, England

16 March 2013

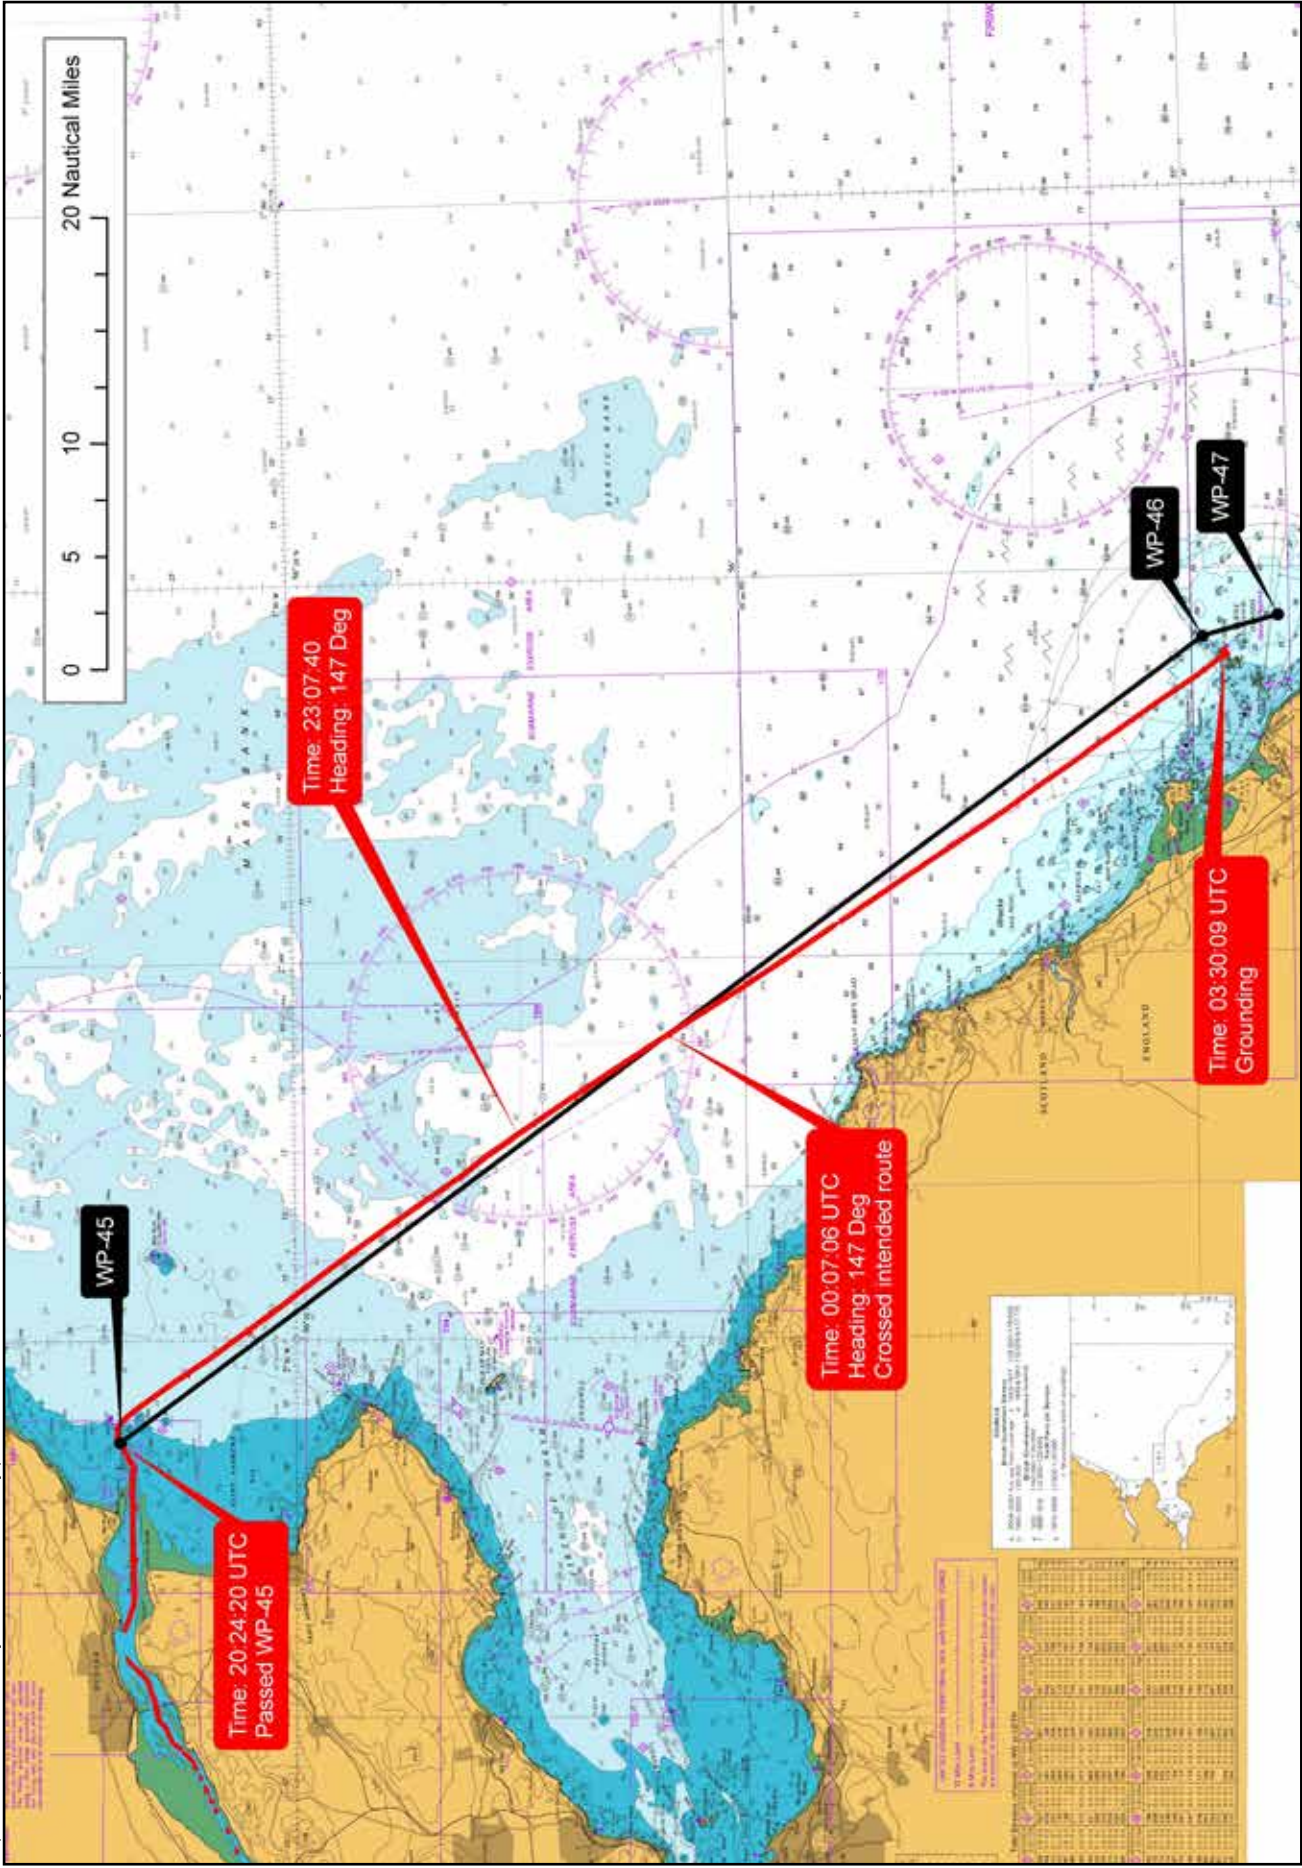
Figure 1: AIS track with ECS waypoints up to the point of grounding

At 0330 on 16 March, *Danio* ran aground on the rocky coast of Longstone Island (**Figure 1**) at a speed of 8 knots. The chief officer was woken by the impact, and on realising the vessel was aground immediately put both engines to half astern.

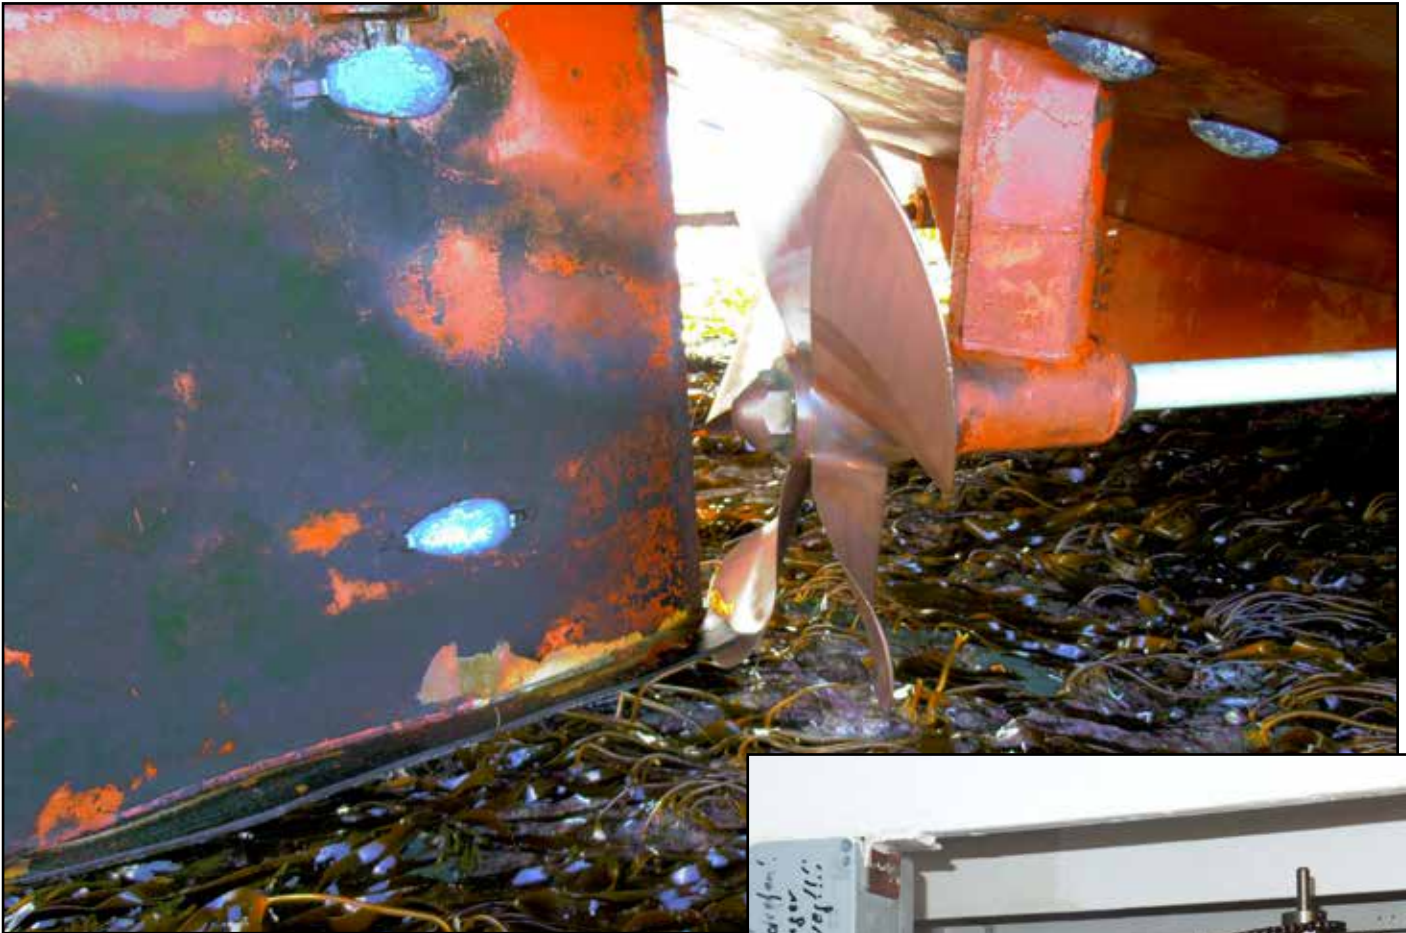
Figure 3: Damage to starboard propeller and rudder (inset: internal damage)

The next day, when the crew of *Danio* carried out an external inspection of the vessel, they noticed that the starboard propeller and rudder were damaged (**Figure 3**) along with several corresponding frames and internal bulkheads.

On 23 April, *Danio* was dry docked at a shipyard in Poland, where approximately 40 tonnes of steelwork were renewed. Both rudders and propellers were also replaced, along with one main engine gearbox. The vessel remained in dry dock until the end of August 2013.

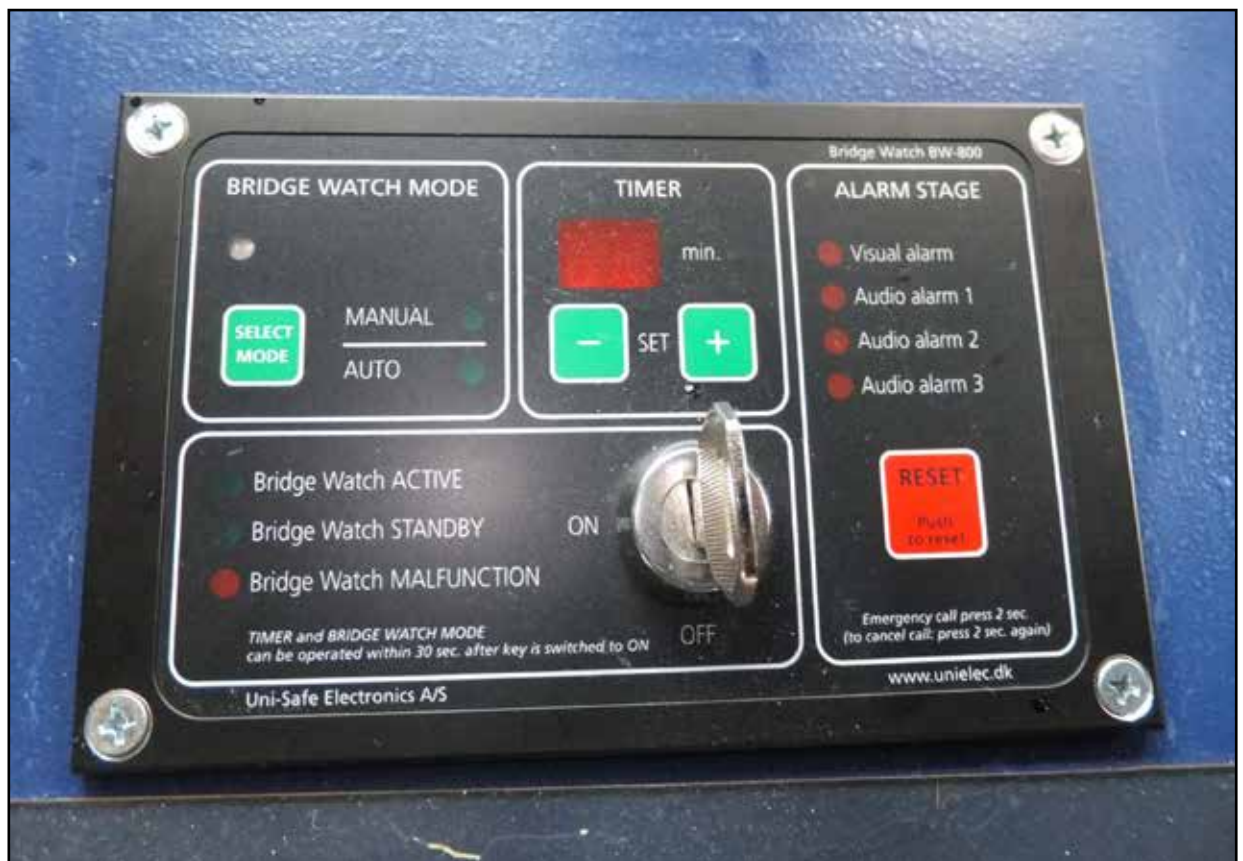
Figure 5: Watch alarm on the bridge

Danio had been fitted with a watch alarm from build. In July 2012, the owners replaced the original watch alarm with a Unielec BW-800 unit that was compliant with the BNWAS performance standards. This system had a key to secure the controls and prevent changes to the settings; however it was standard practice on board for the key to be left in the panel (**Figure 5**).

The master and chief officer were not familiar with the unit and neither recalled the BNWAS ever being used. There were no written policy statements about the BNWAS from the owners of the vessel, and its use was not mandated by the vessel's SMS.

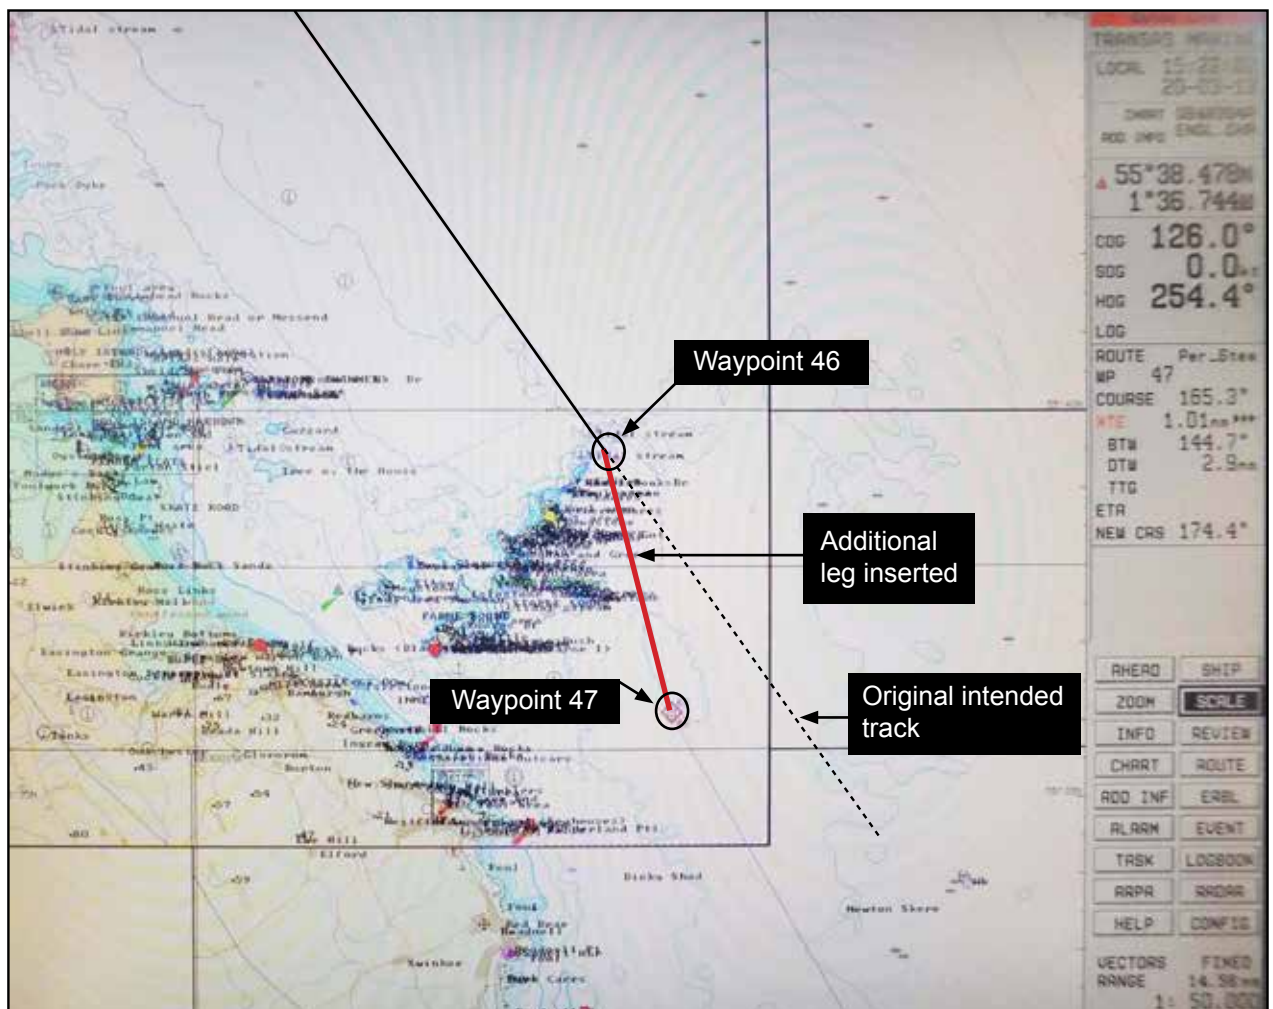
Figure 7: Additional leg inserted in the passage plan on ECS

The chief officer added an additional leg (**Figure 7**) on the ECS during his watch. This routed the vessel nearer to the coast, after passing the Farne Islands. Neither the intended route on the paper chart nor the passage plan was altered.

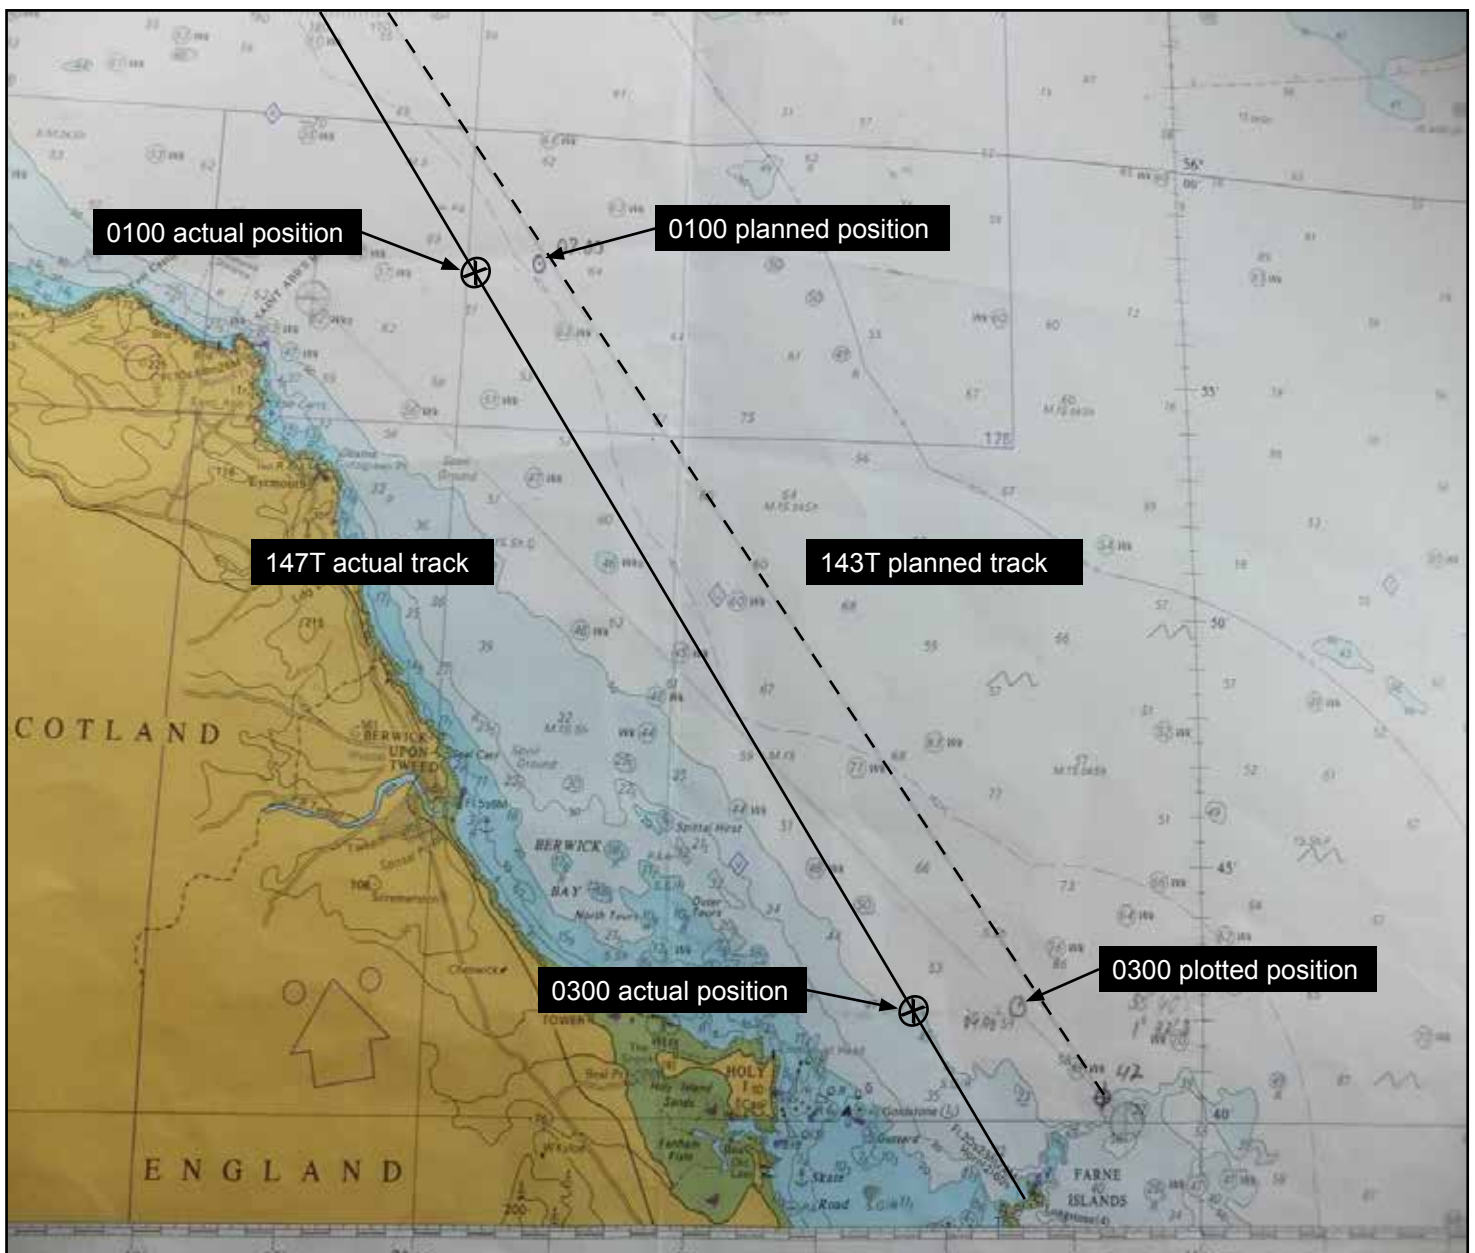
Figure 8: Inconsistent positions

The ship's positions at 0100 and 0300³ on 16 March, plotted on the paper chart, were respectively 0.94nm and 2.7nm east of the actual track of the vessel as recorded by the vessel's AIS track (**Figure 8**). The chief officer admitted to having plotted the 0300 position after the accident. Although the waypoints were marked on the chart as per the passage plan, they did not correspond to the waypoints on the ECS (**Figure 9**).

³ These are UTC times, whereas the times indicated on the chart in pencil at **Figure 8** are ship's time (UTC+1).
