REPUBLIC OF BULGARIA
NATIONAL AIR, MARITIME AND RAIL ACCIDENT INVESTIGATION BOARD

FINAL REPORT

THE INVESTIGATION OF A SERIOUS MARITIME ACCIDENT —

**Grounding of the motor vessel “Vera Su” on the Bulgarian coast
on 20.09.2021.**

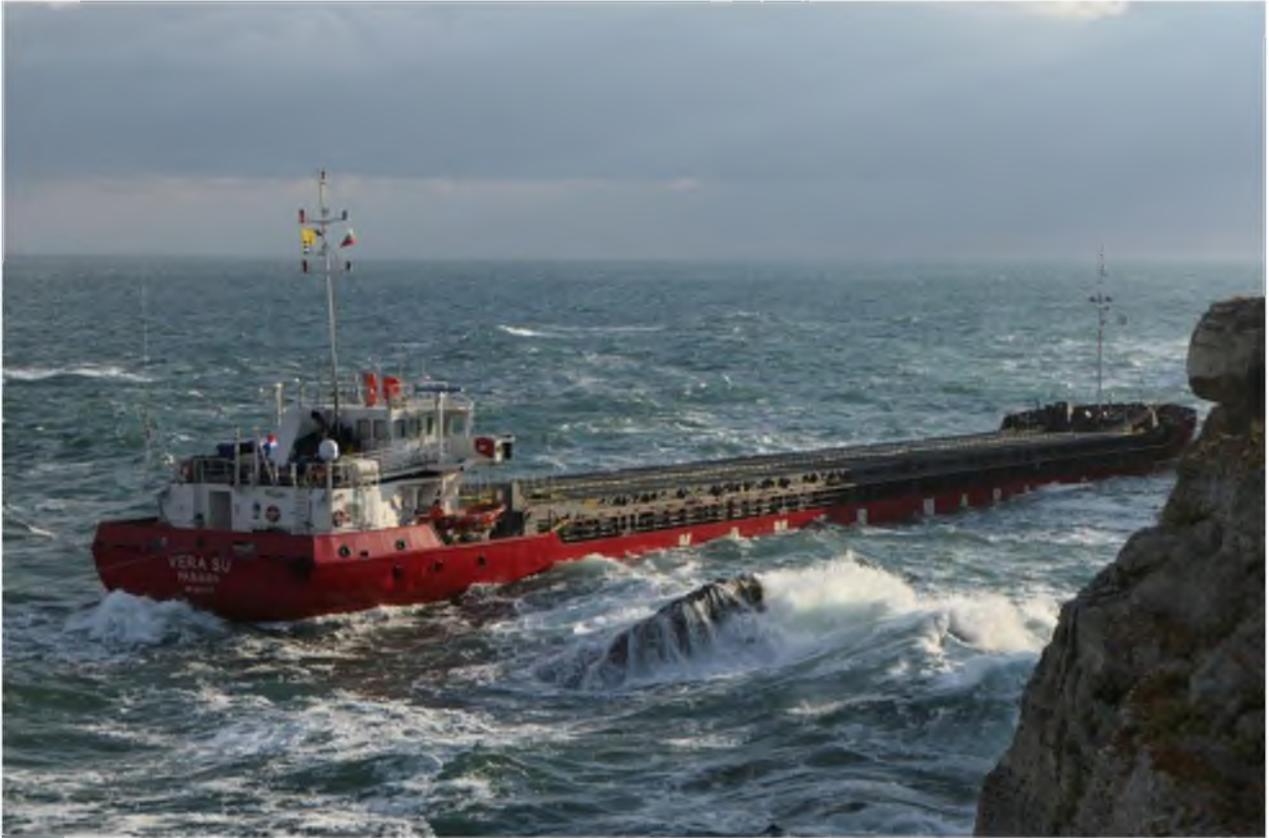
Fig. 1 — Grounded m/v “Vera Su”

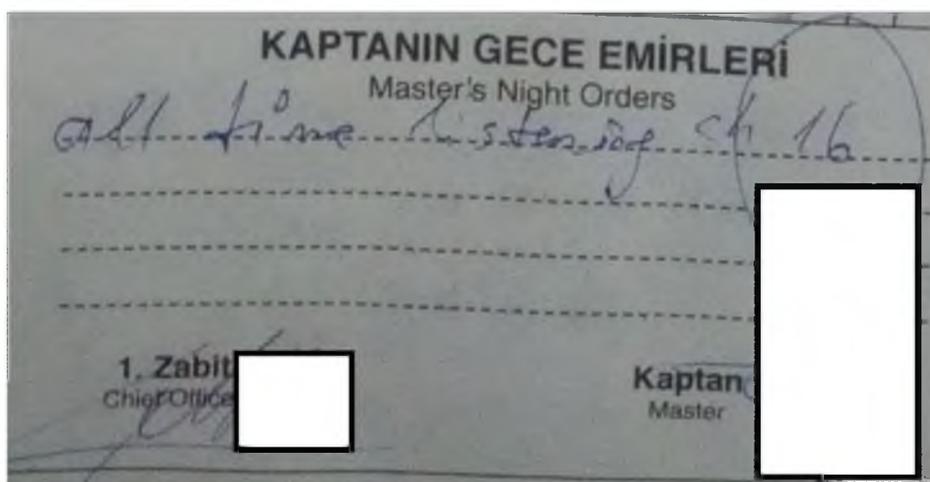
In the column orders of the master for the night of 19.09.2021 against 20.09.2021, the evening before the accident, there was only a record: "*all time listening ch 16*". The record was made on page 263 of the ship's logbook.

Fig. 4 — the master's order for the night watches on 19-20.09.2021

For the night of 19.09.2021 against 20.09.2021 no Master’s night orders for the watchkeeping officers were made.

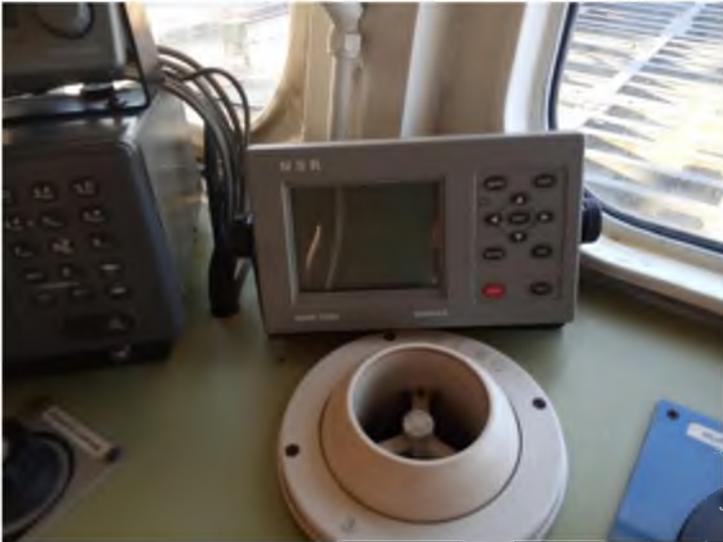
Fig. 5 — Control unit of BNWAS on the bridge

The investigation found that the BNWAS dominant period was set for 3 min. At the time of the accident, the system operated in MANUAL OFF mode, in which the alarms were not activated.

All this indicates that either the crew was not aware of the principles and modes of operation of the BNWAS on the bridge, or that the master's control of the other officers of the watch and the both OOW's control of the operational mode of the navigational equipment on the bridge was lacking on board the vessel. The last two hypotheses are more credible, which was a gross violation of the requirements of Reg. 19, para 2.2.3, Chapter V of SOLAS'74 and Chapter VIII, Part 4-1, para 26 of the STCW Code and of the Company's SMS.

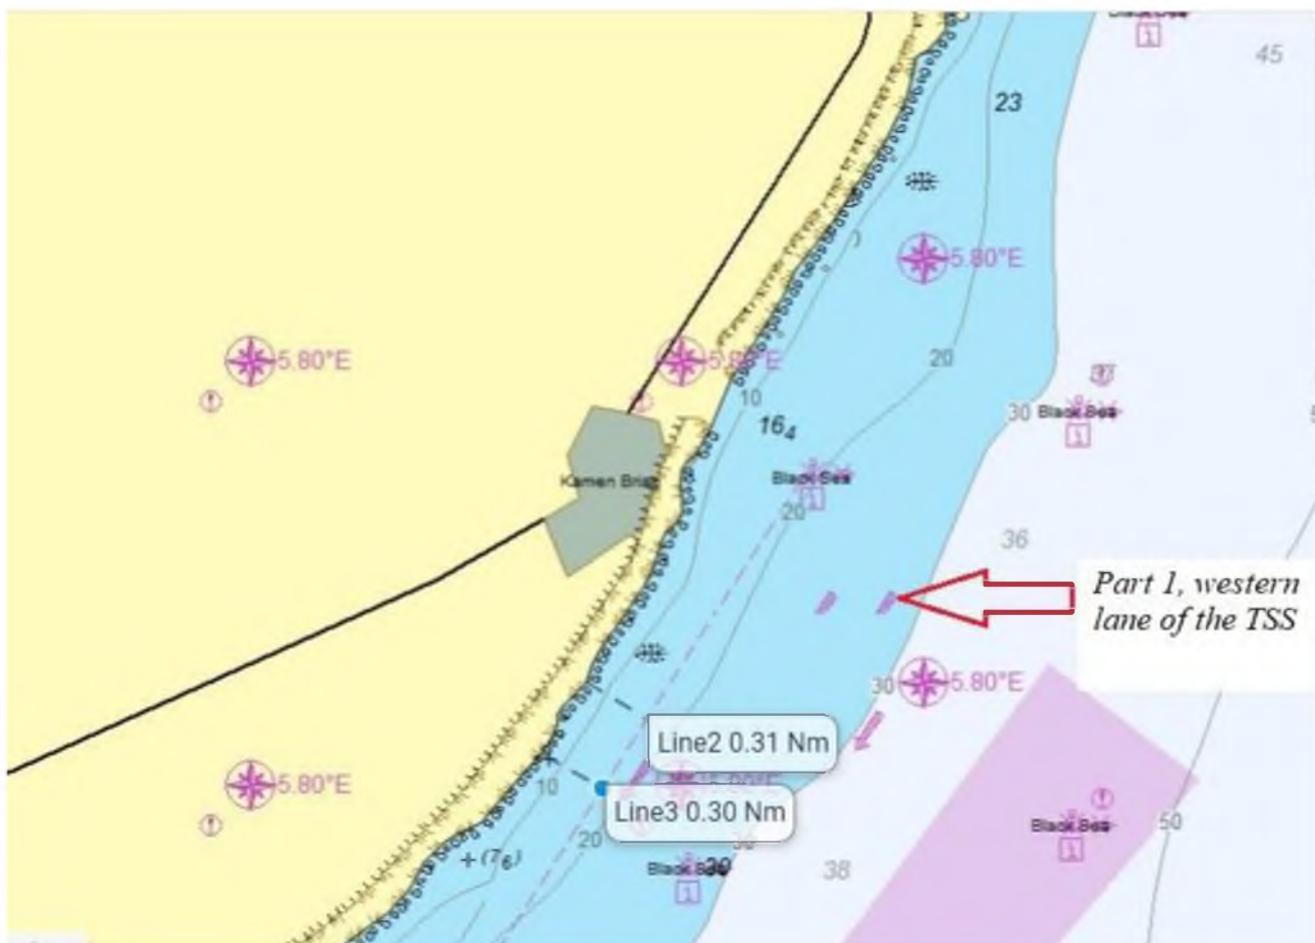
Fig. 7 — Part I, western lane of the Traffic Separation Scheme. The nearest points from the border to the coast are indicated (Line 2 and Line 3).

For vessels heading generally north-south, the points for joining in the Traffic Separation Scheme are in the western lanes, too close to the coast (especially in Part I, western lane), resulting in a small sea area for manoeuvring in close quarter situations with other ships and a small response time of OOW, whether it is a collision avoidance situation or a risk of stranding due to misdetermination of the way point and turning time for joining the traffic lane.

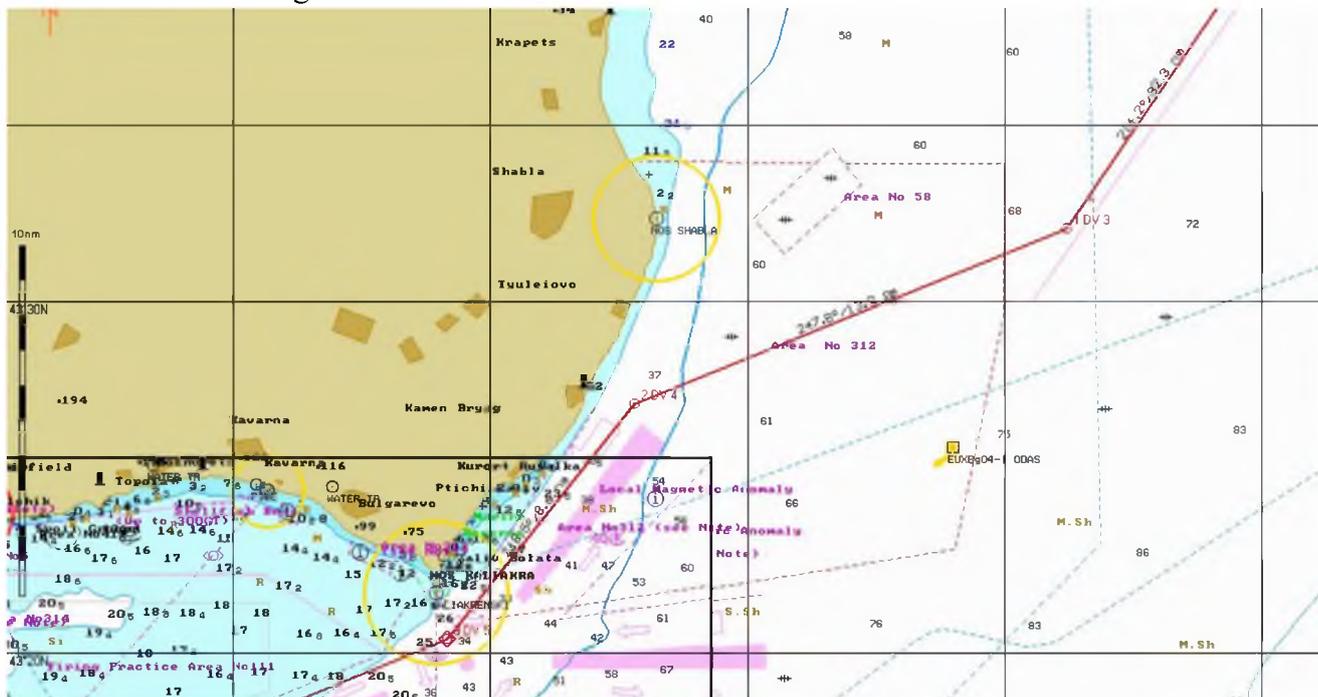
Fig. 8 — Final phase of the deviation of passage plan in the vessel's area of joining the Traffic Separation Scheme and cape Kaliakra

During the passage, at the direction of the master, the courses of the vessel were adjusted so that the navigation to be made closer to the shore (Figure 8, compare with figure 9). The additional passage plan for deviation from the original route (deviation plan) has not been signed by anyone.

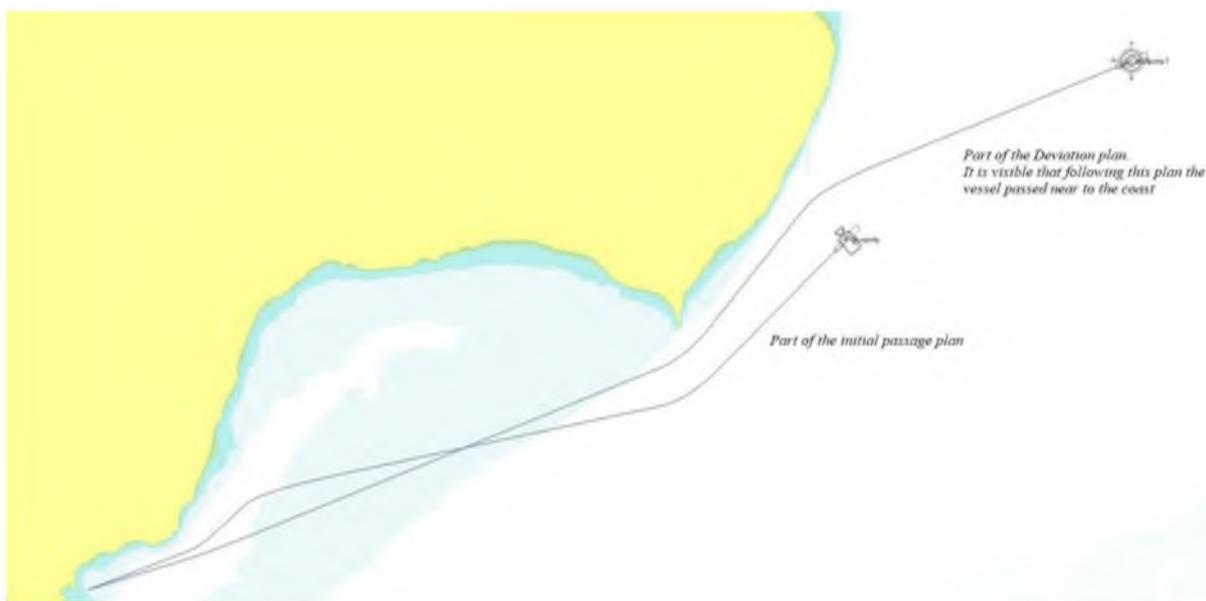
Fig. 9 — Comparison between the original passage plan and the deviation plane - final phase by the order of the master.

The reason for the change, according to the master's testimony, was the sharp deterioration of the weather and the need for a better Internet connection in the final stage of the passage, necessary to broadcast messages to the coastal authorities and the shipowner.

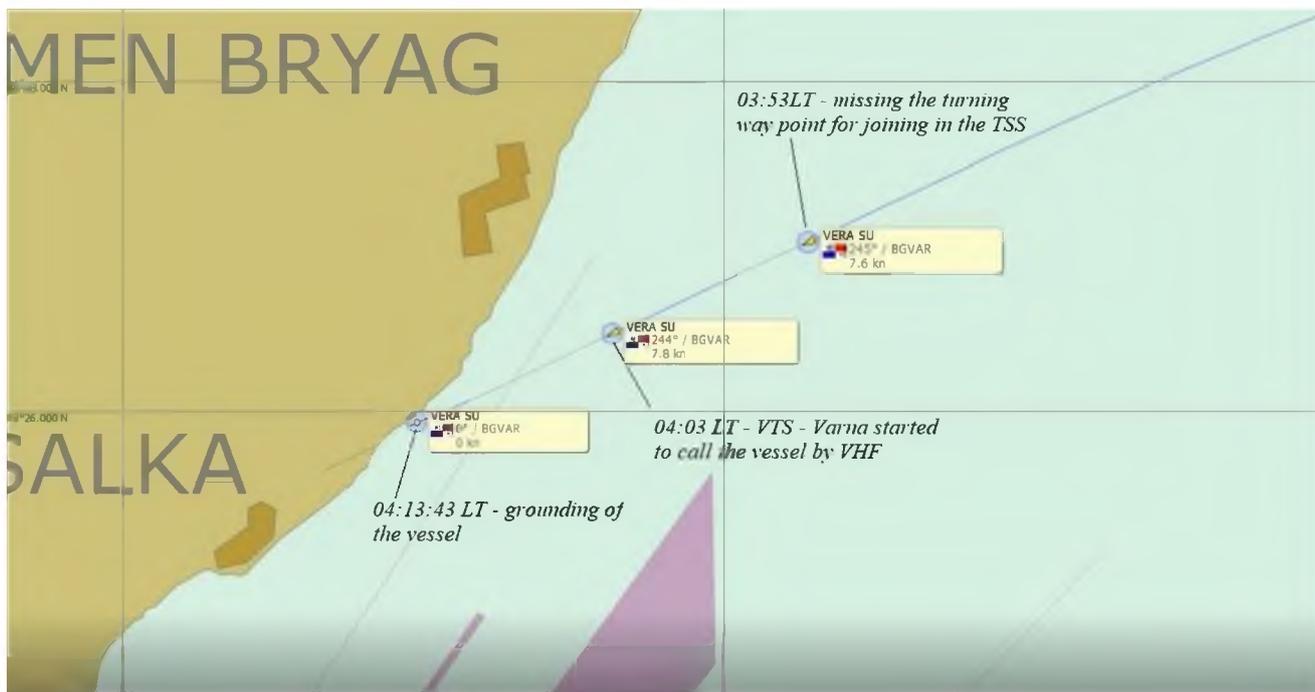
At 04:13:43, with a course of 246° and speed 7.8 knots, the vessel grounded on the rocky coast in the area of Yailata Protected Area (Figure 10). The second officer was awakened by the loud noise and the squeezing of the ship, assessed the situation, gave a stop to the main engine and descended into the living quarters to wake up the master, the chief officer and the seaman.

Fig. 10 — Final stages of the ship's passage — missed a planned turning way point, start calls from the shore and the grounding.

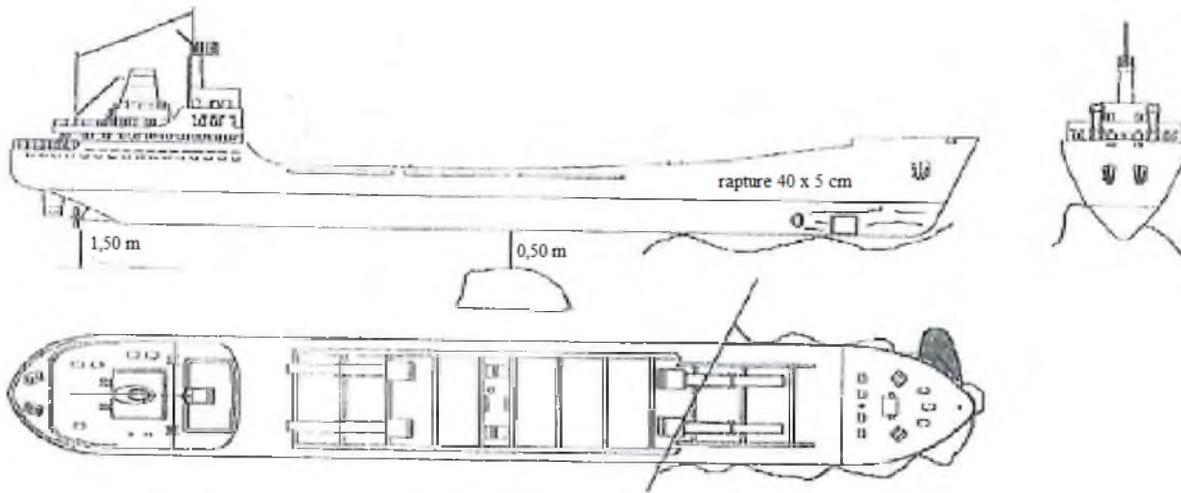
Already on the day of the grounding, at the initiative of the shipowner, an underwater inspection was carried out on the vessel, which found holes only in the ballast tanks of the ship. The bow of the ship was found to be firmly trapped in the rocks, and the middle and stern, including the screw propeller, were free (Figure 11).

The inspection found damage to the hull as a result of contact with the rocky bottom in the area, consisting of undercuts, ruptures and deformations on both sides of the vessel, reaching a distance of about 25 m from the bow to the stern of the vessel.

Fig. 11 — Places of contact of the hull with the bottom, at the time the vessel's grounding

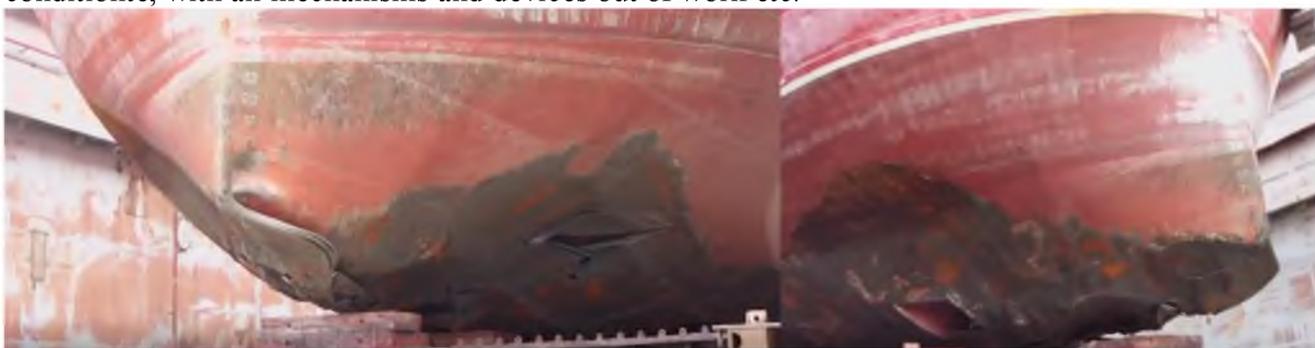
Fig. 14 Damages of the ship in the bow (port and starboard)

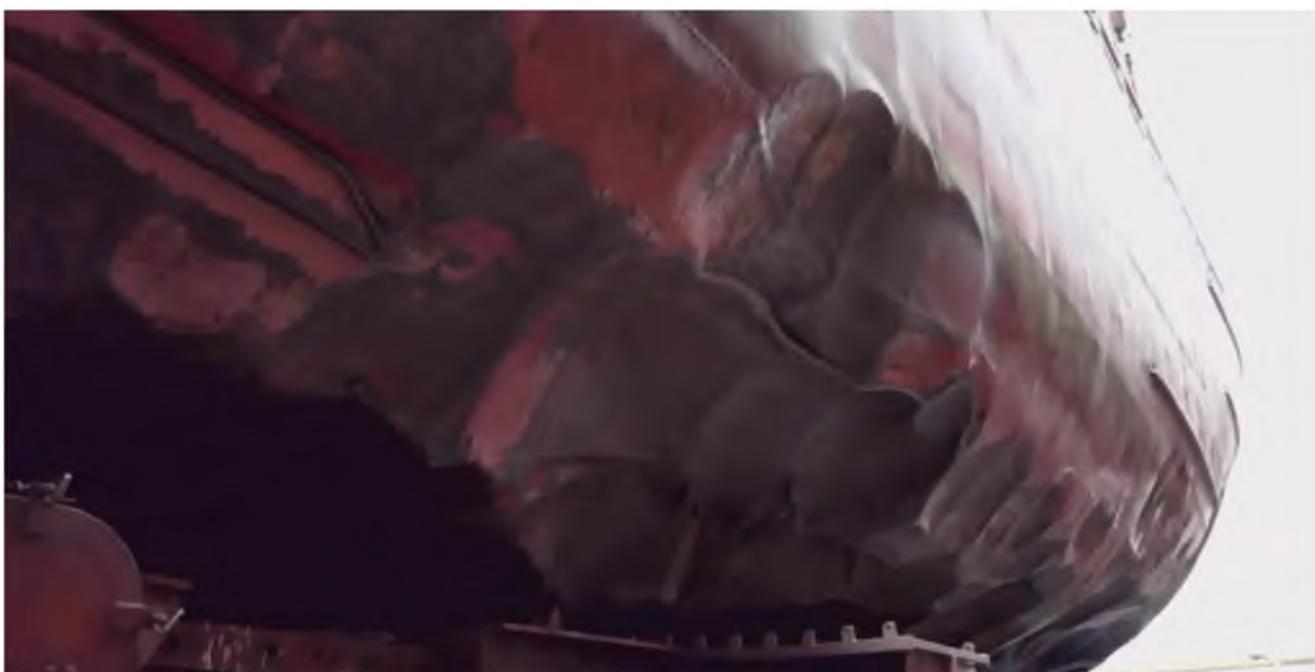
Fig. 15 Significant bends around the midship starboard side

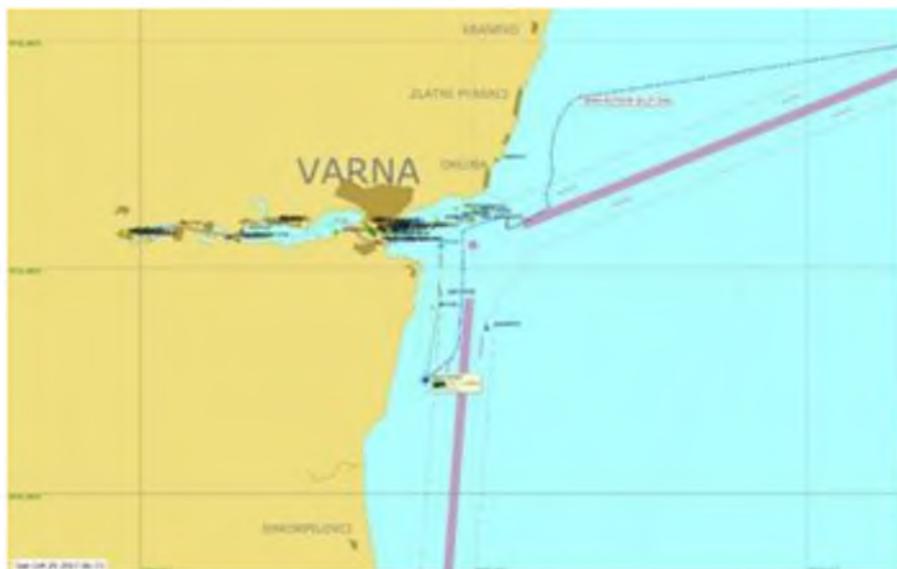
Fig. 16 — Movement of m/f SLAVYANIN. The movement towards “Golden Sands” is visible.

A subsequent inspection by the port authorities found that the OOW had become ill and fainted on the navigation bridge while the duty AB was sent to carry out a ship's tour and to check the cargo shifting. The alarm of the BNWAS was switched off.

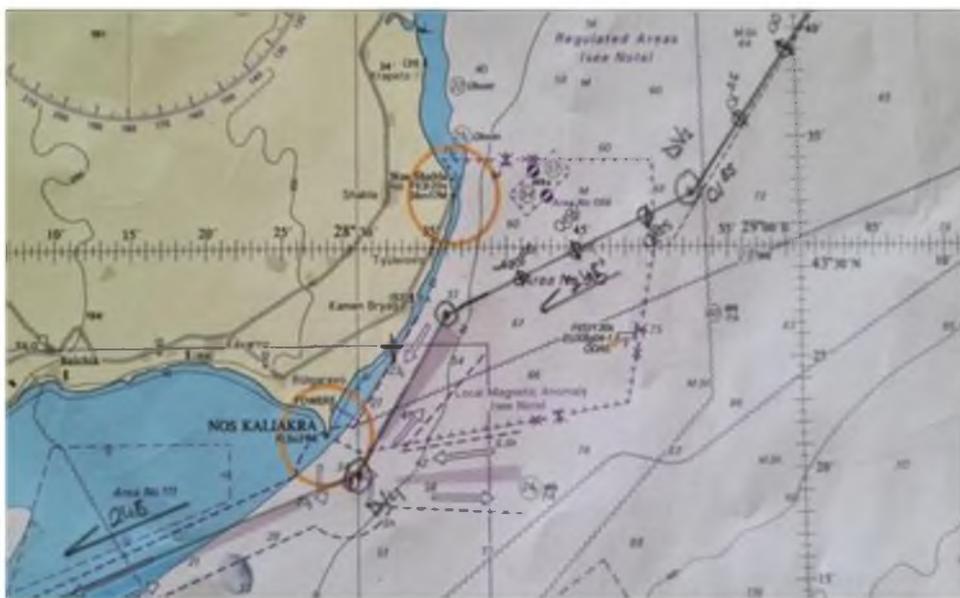
In the course of the investigation, it was established that the courses of the passage plan were drawn only on small-scale charts BAC 2232 and BAC 2230. On the large-scale charts, including navigating near the coast (BAC 2283) in the area of Kamen Bryag, where the ship was stranded, and Cape Kaliakra, as well as on the chart for the approach to Varna (BAC 2285), the courses were not drawn at all. This was a violation of Chapter V, Reg. 34 of SOLAS'74, and reference to IMO Resolution A.893 (21) of 25.11.1999, paragraph 1.3, paragraph 3.1 and paragraph 3.2.1.

Fig. 17 — Part of the passage plan in the area of the stranding drawn by the second officer of a navigational chart.

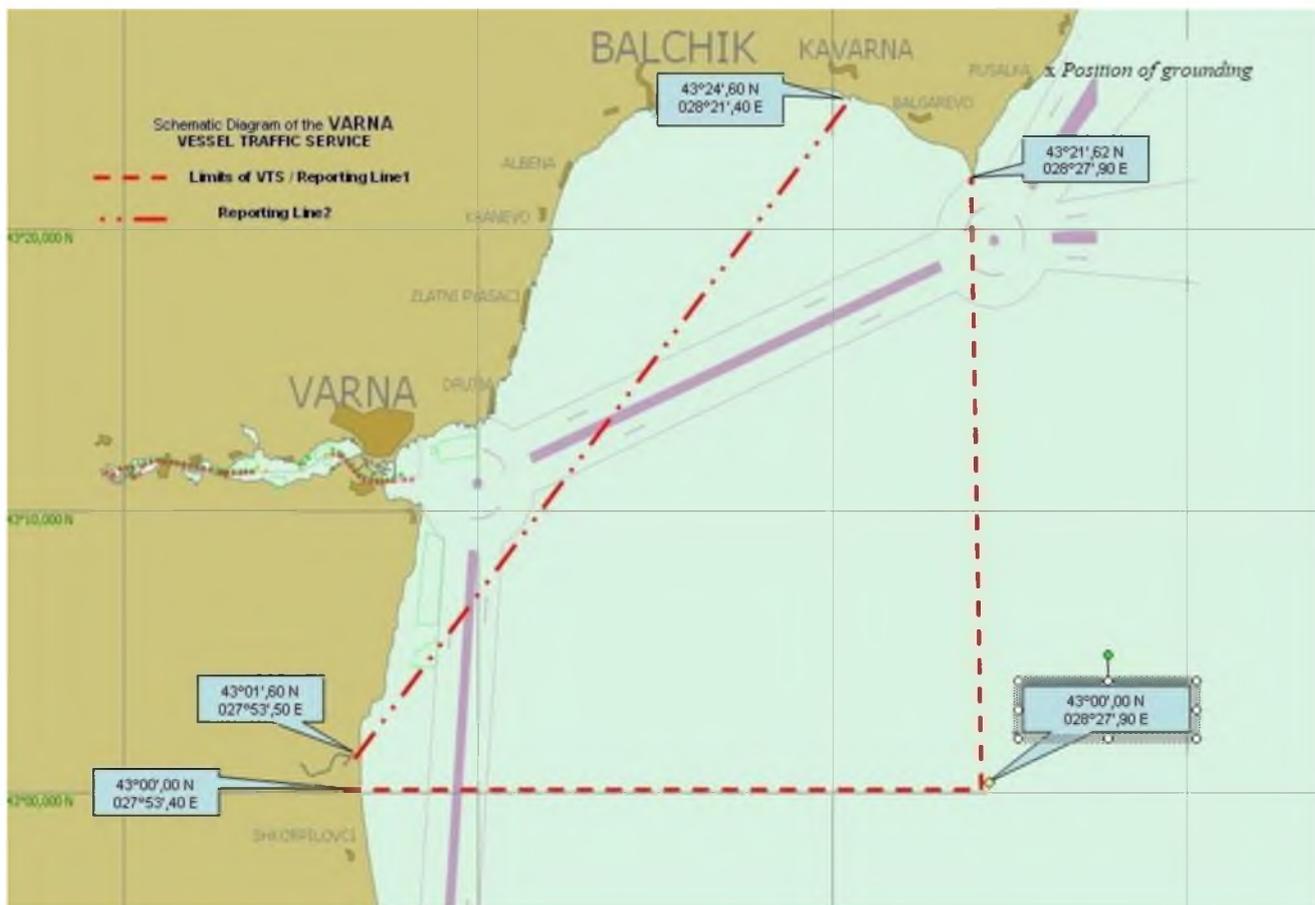
The location of the casualty of m/v “Vera Su” is outside the responsible area of the VTS - Varna, but within the scope (immediate proximity) of the Traffic Separation Scheme (Northern part), which raises reasonable doubts about a failure in the design of the boundaries of the scope of the responsible area.

Fig. 18 — Areas served by the VTS - Varna. The part of the TSS which is not covered by the area is visible.
