National Transportation Safety Board

Marine Accident Brief

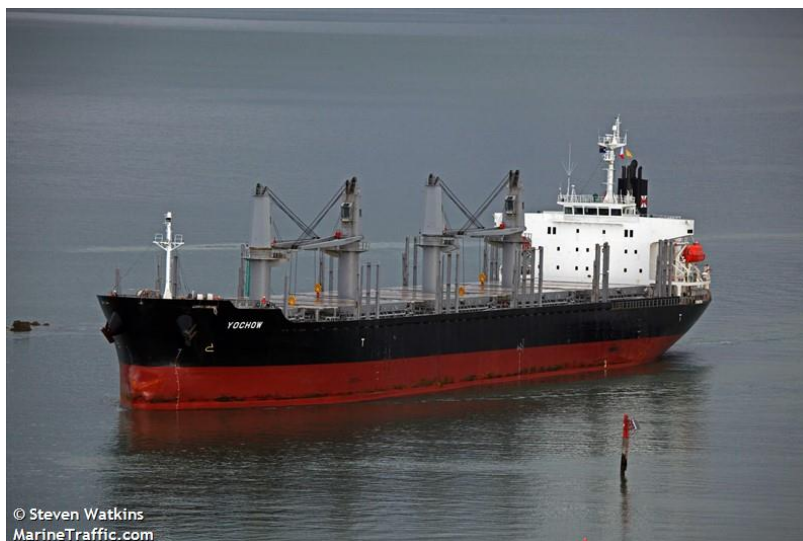
Bulk carrier *Yochow* under way.

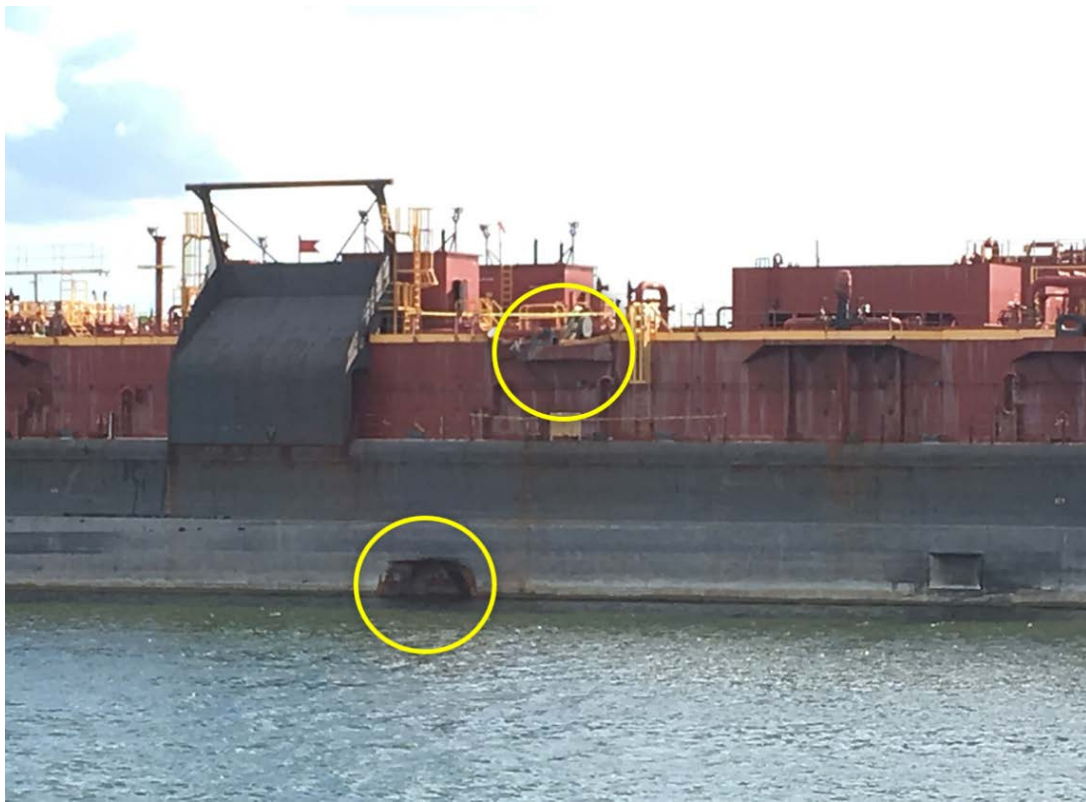
Damage to *OSG 243*, port side. Yellow circles identify, at top, cantilever deck damaged by *Yochow*'s bow rake and, at bottom, side shell at waterline in no. 5P ballast tank penetrated by bulk carrier's bulbous bow.

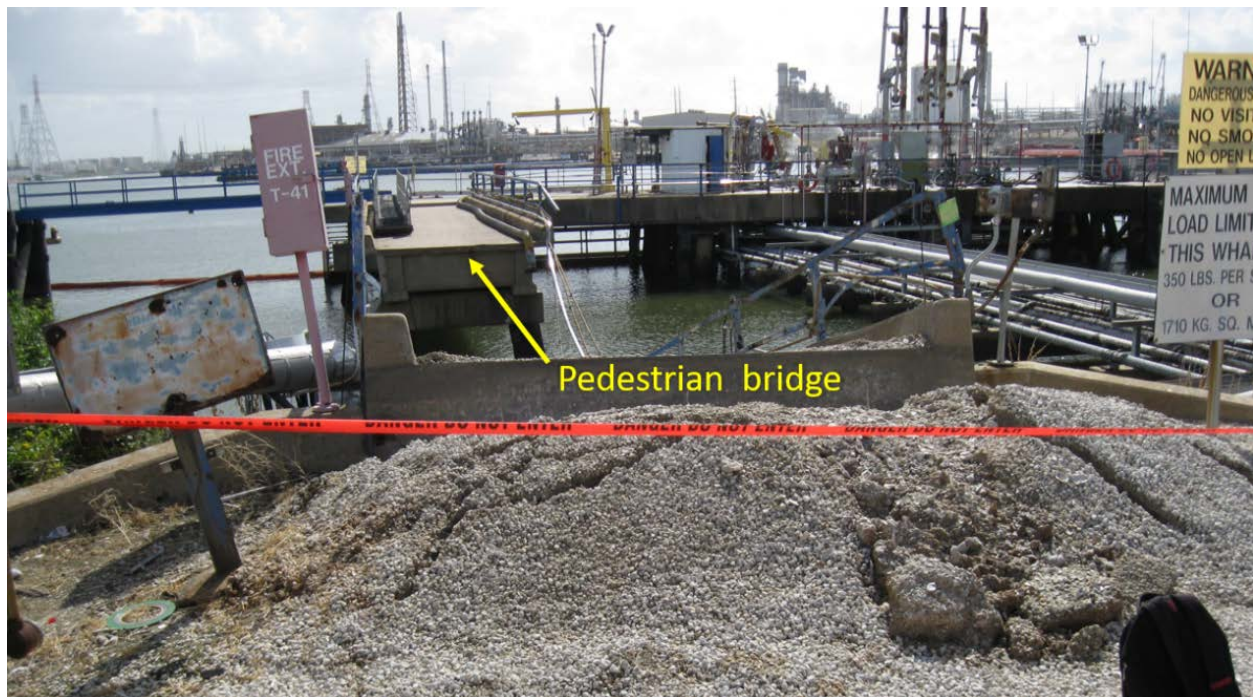
TPC facility on Houston Ship Channel. The impact pushed the pedestrian bridge off its support, crushing conduit below. (Photo by Coast Guard)

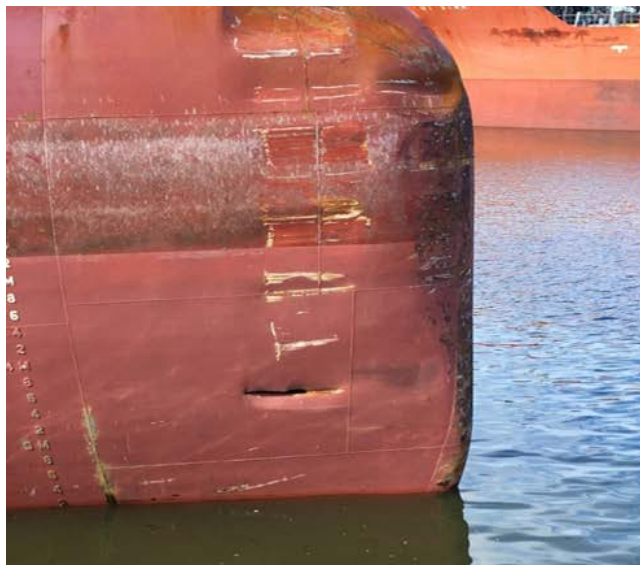
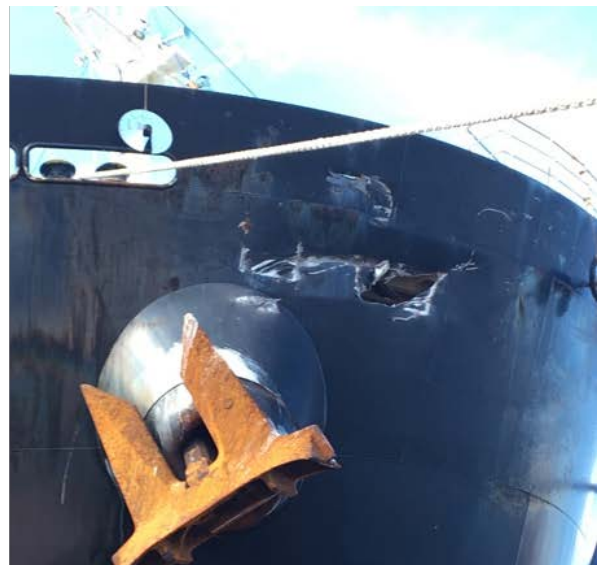
Yochow's bow showing, at left, holed bulbous bow and depth of penetration and, at right, damaged upper starboard bow.
