Report on the investigation of
the grounding of

Danio

off Longstone, Farne Islands, England

16 March 2013

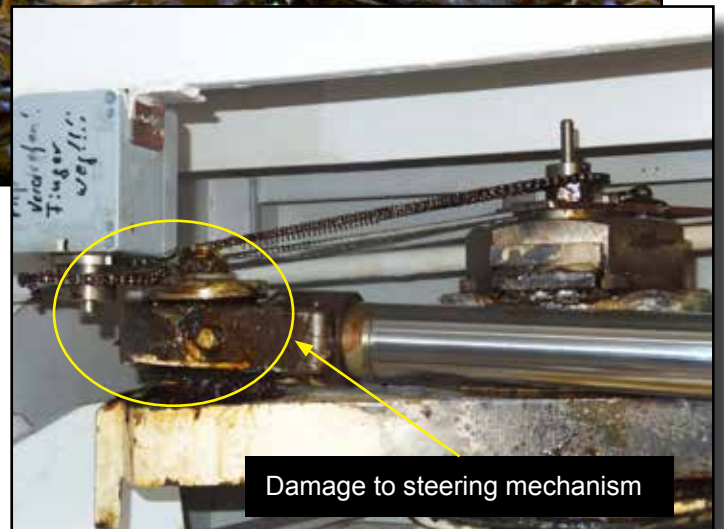
The next day, when the crew of *Danio* carried out an external inspection of the vessel, they noticed that the starboard propeller and rudder were damaged (**Figure 3**) along with several corresponding frames and internal bulkheads.

Figure 3: Damage to starboard propeller and rudder (inset: internal damage)

On 23 April, *Danio* was dry docked at a shipyard in Poland, where approximately 40 tonnes of steelwork were renewed. Both rudders and propellers were also replaced, along with one main engine gearbox. The vessel remained in dry dock until the end of August 2013.
