REPUBLIC OF BULGARIA
NATIONAL AIR, MARITIME AND RAIL ACCIDENT INVESTIGATION BOARD

FINAL REPORT

THE INVESTIGATION OF A SERIOUS MARITIME ACCIDENT —

**Grounding of the motor vessel “Vera Su” on the Bulgarian coast
on 20.09.2021.**

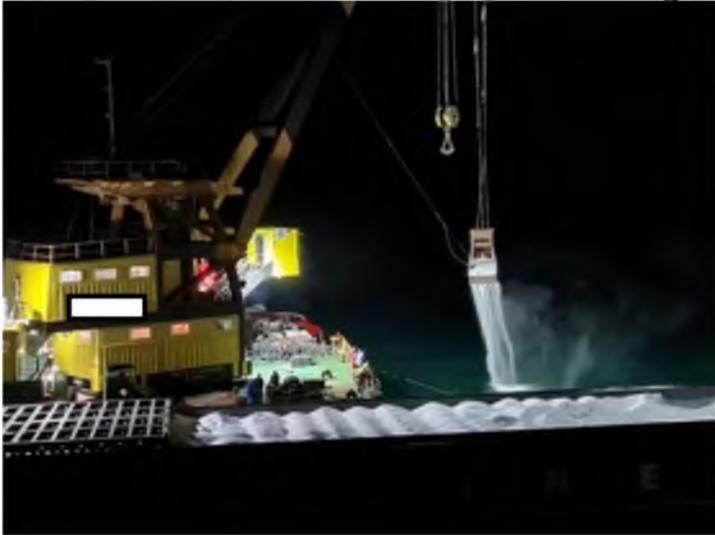
In the evening of the same day, an attempt was made to refloat the vessel by initial lightening by discharging part of the cargo with a floating crane and its subsequent loading on a barge. The partial unloading operation was discontinued due to a noticeable significant leakage of part of the cargo from the grab (Figure 12). The unloading operation lasts 2 hours and a minimum quantity of cargo was unloaded.

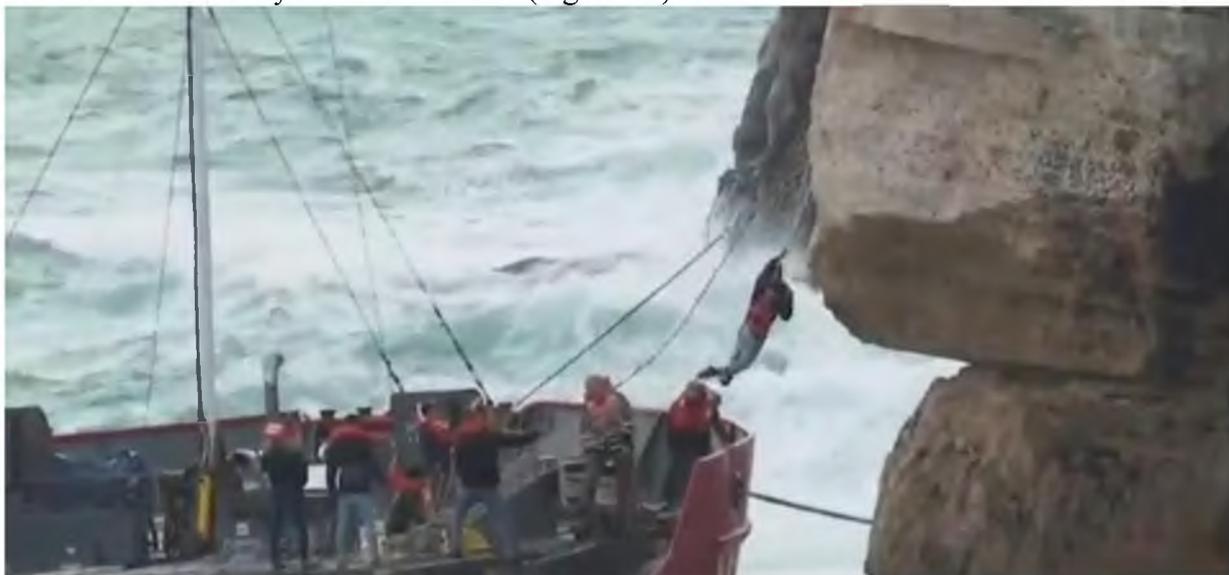
Fig. 13 - Crew evacuation on 06.10.2021

On 06.10.2021, the master of the vessel announced her abandonment by the crew in view of the impending deterioration of the weather. The Harbor master of Varna ordered the master of the vessel to close all doors, cranes, valves, emergency exits, etc. and to stop the vessel's diesel generators. The crew was successfully evacuated ashore (Figure 13).
